## Earthquake of June 23, 2020, M 7.4, Oaxaca, Mexico

Velázquez-Bucio M.M., Porfido S., Michetti A.M.

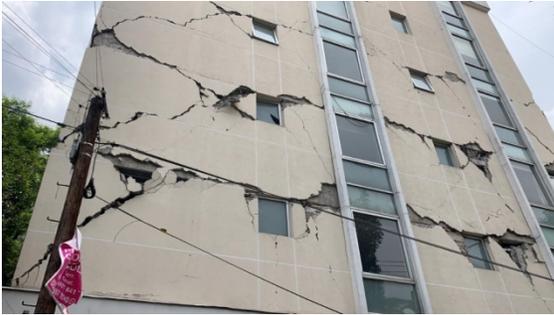
Figure 2. Building affected by the 2017 earthquake was affected again by the June 23, 2020 earthquake; the building is located between Tepic and Monterrey streets, in Colonia Roma, Mexico City. Photo, La Jornada newspaper.

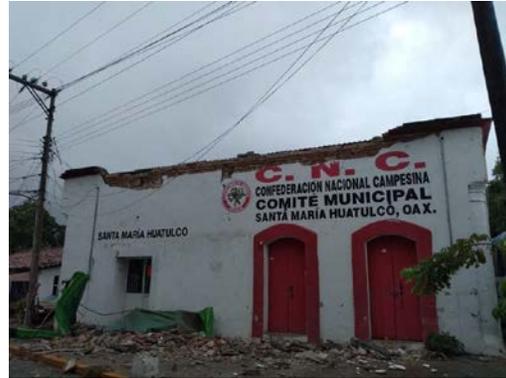
Figure 3. Building affected by the June 23, 2020 earthquake in Santa María Huatulco, Oaxaca.

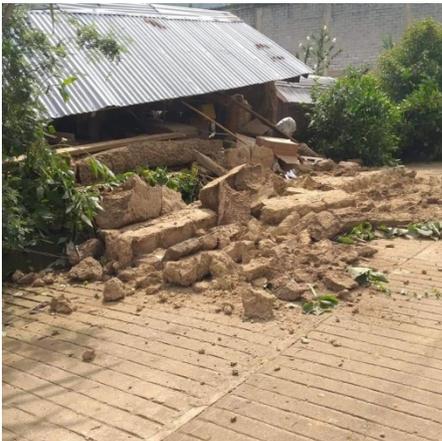
Figure 4. Wall of adobe clay house. San Juan Ozolotepec, Oaxaca.

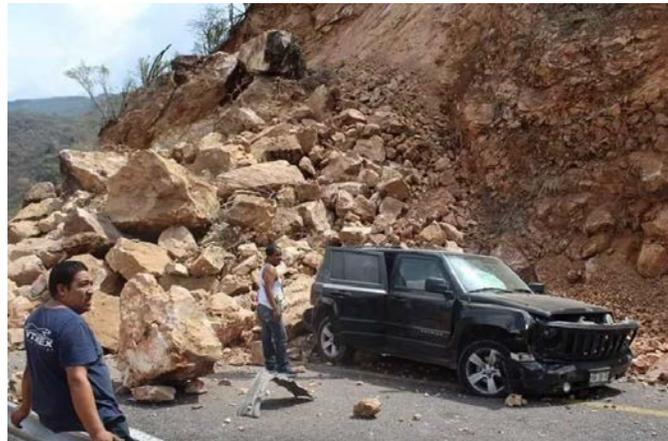
Figure 5. Landslide on Oaxaca-Tehuantepec highway, Km 118. I = VIII ESI-2007.

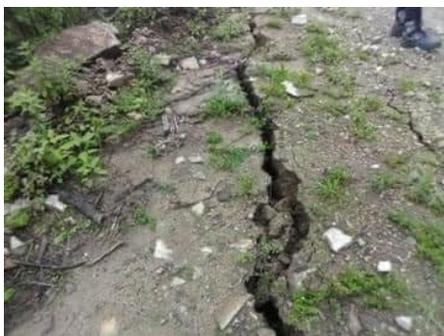
Figure 6. Crack in sandy terrain. Crucecitas, Oaxaca. I = VII ESI-2007.

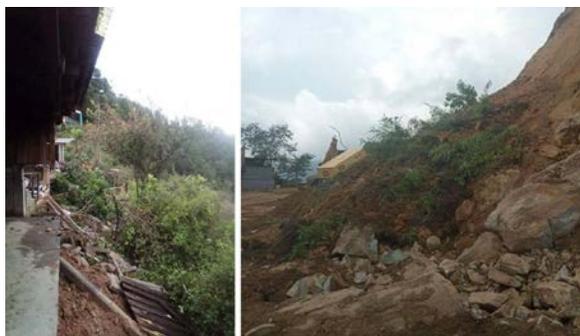
Figure 7. Rock fall and landslides in San Sebastian Río Hondo, Oaxaca. I = VII ESI-2007.

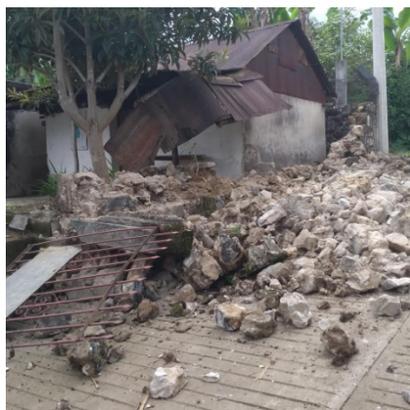
Figure 8. Rock wall collapse in Santa Cruz Ozolotepec, Oaxaca.

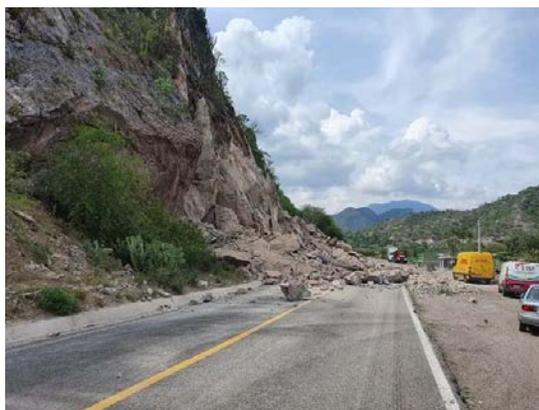
Figure 9. Landslide on the Totolapan road, Oaxaca. I = VIII ESI-2007.

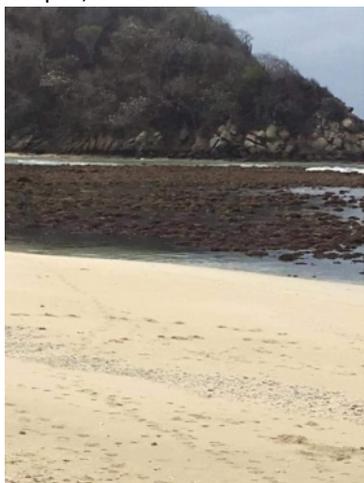
Figure 10. Tsunami, secondary effect of the Crucecita earthquake, in Huatulco, Oaxaca. I = VII ESI-2007.

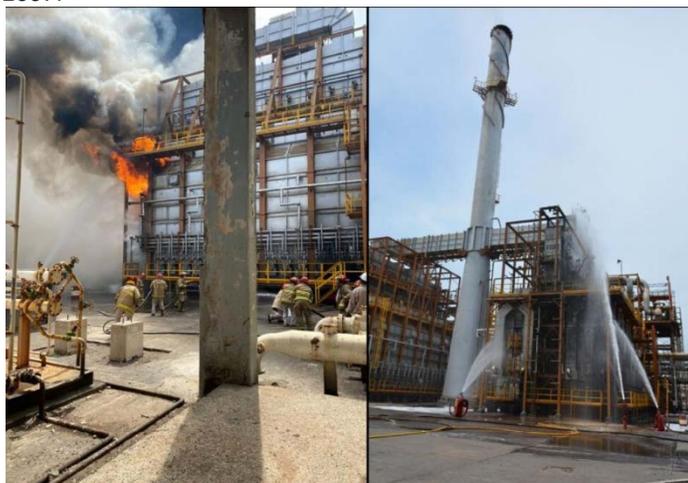
Figure 11. The "Antonio Dovalí Jaime" refinery, in Salina Cruz, Oaxaca, registered a shot in the turbogenerators and in the caldera, which caused a fire. Photo taken from @Pemex.
