The Napa Earthquake, California (M=6; 24/08/2014)

Post-seismic survey report, with special focus
on surface faulting

RT/PRP-DGE/2015-00018

Stéphane Baize, Oona Scotti

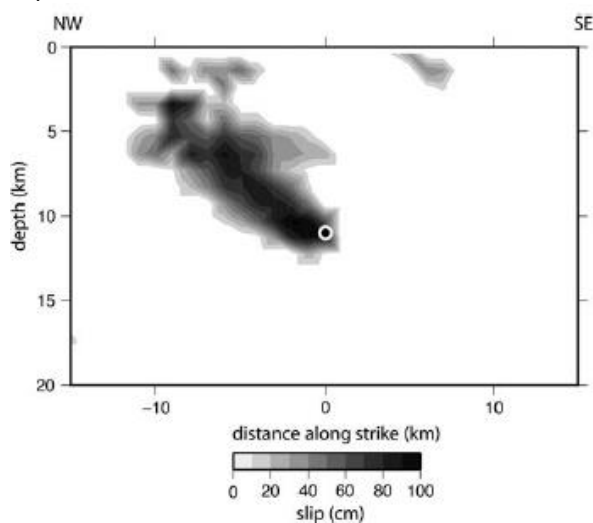
Figure 2: Slip model for the M6 earthquake, obtained from inversion of seismic data (white circle : hypocenter). From Brocher et al. (2015)

Preliminary slip models were published by the USGS few hours after the quake, then updated with new processing. Based on the inversion of GPS or seismological data, they show that the rupture was initiated at depth in the south and then propagated to the north and up-dip to the surface. Maximum values of slip at depth come close to 1 meter (Figure 2). The fault slip history model suggests explanations for the damages observed in Napa city and its suburbs:

- first, the main slip zone is located right below the city, which can be an explanation to the largest deformation in this area, close to the fault;
- second, the focal mechanism being a pure right lateral strike-slip, the city area lies in an extensional quadrant of the deformation, which is likely to promote secondary fault breaks;
- finally, the up-dip and northward rupture propagation focused radiated wave energy toward the city and possibly increased damages there.

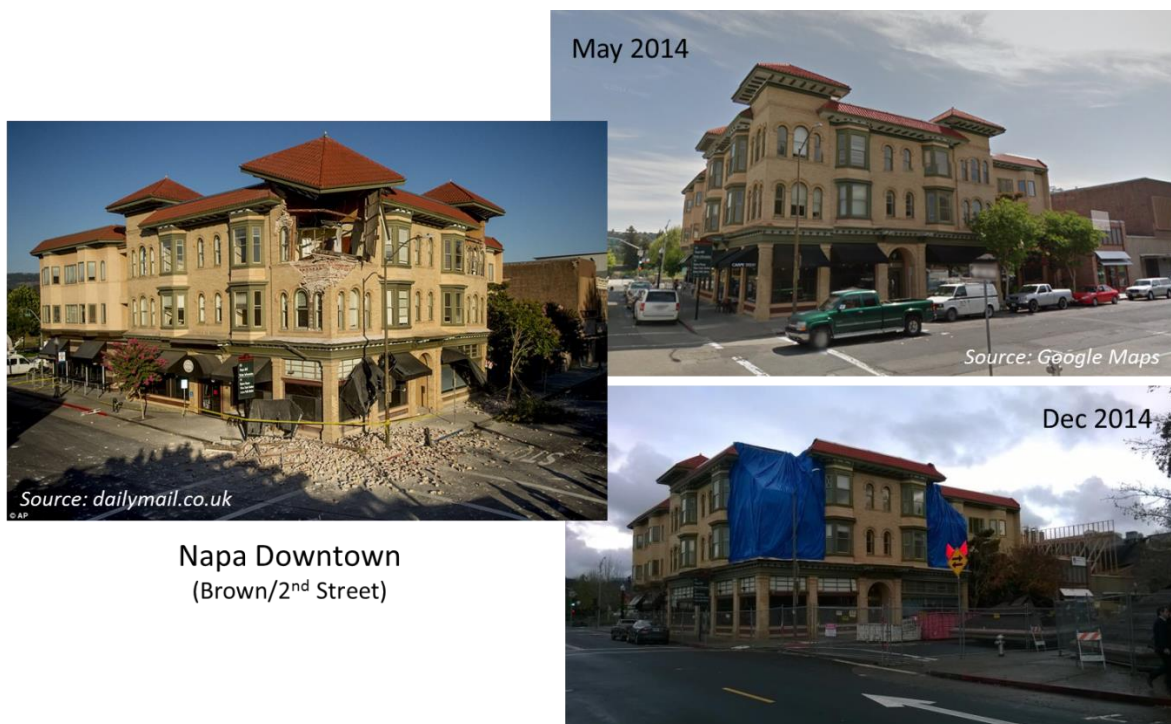
Figure 4: Damages to a masonry building in the historical Napa center (Brown St-2nd St)

The event was responsible for significant damages mostly focused in Napa, 10 km north of the epicenter. Damages extend from Browns Valley to the west to Napa Downtown, where some residential buildings suffered shifting on their foundations, failure of walls or collapse of chimneys. In the historic part of Napa, masonry buildings were also severely damaged (Figure 4). Building inspectors examined hundreds of buildings which were ranked as

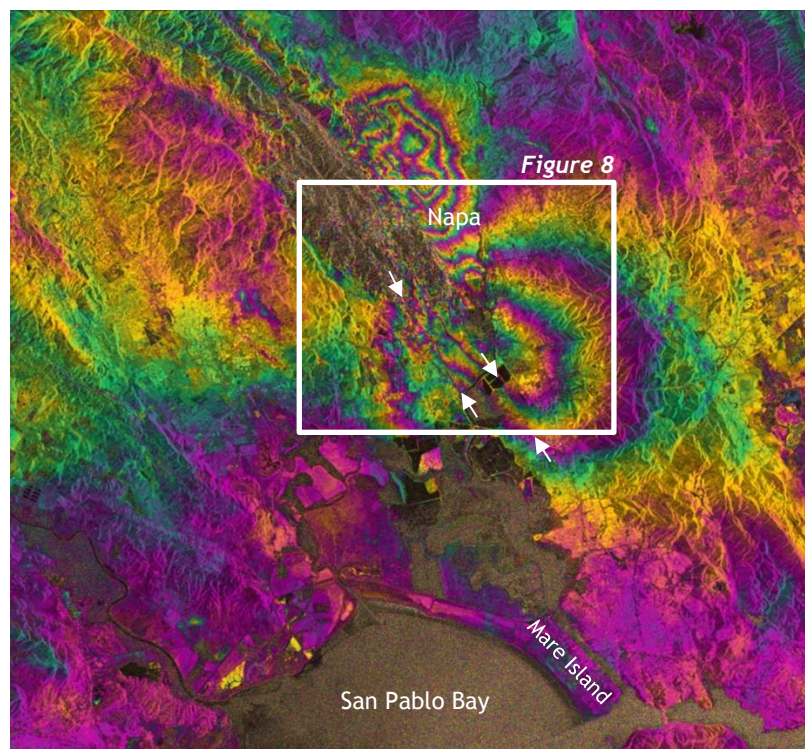
Figure 7: InSAR interferogram calculated with Sentinel-1 radar data. Source ESA/COMET, available at <http://www.esa.int/>. White arrows indicate the location of surface faults that can be inferred from this dataset.

large-scale ground deformation during the earthquake, which have induced phase changes in radar signal appearing as the rainbow-colored shapes. These lobes are typical of strike-slip earthquake signature on interferometry images. Each fringe corresponds to a ground displacement of 28 mm toward or away from the satellite. The fault is visible as two short strands marked by white arrows, where fringes are disrupted: the eastern one crosses the Napa airport where 1 cm right-lateral offset has been measured on the field; the western strand coincides with the southernmost part of the main rupture trace in the Cuttings Wharf area, where total slip is estimated around 30-35 cm. The northern section of the main rupture strand is obscured (no fringes shown) because no correlation could be found between the pre- and post-radar datasets (Figure 7).

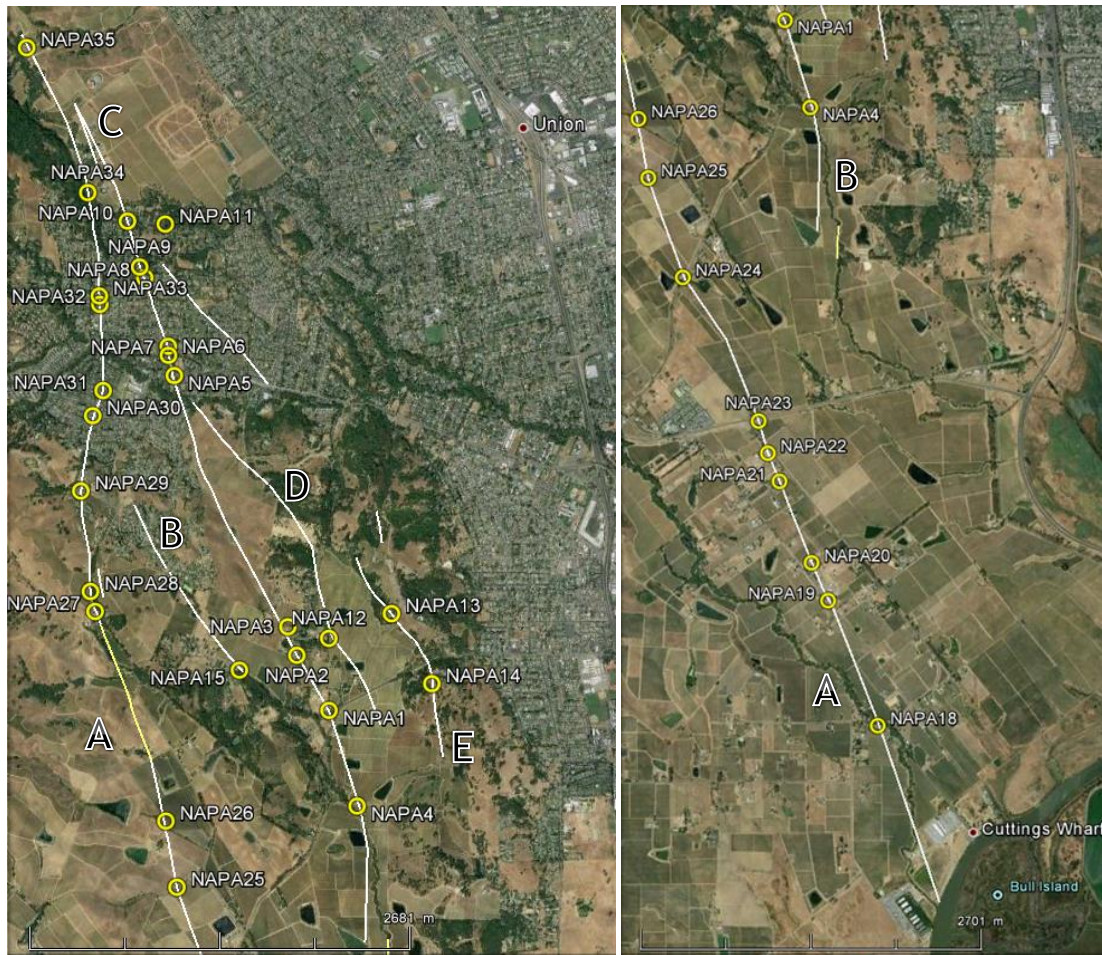
Figure 9 : Database of field slip measurements plotted on the USGS earthquake fault traces (base map: Google Earth image).

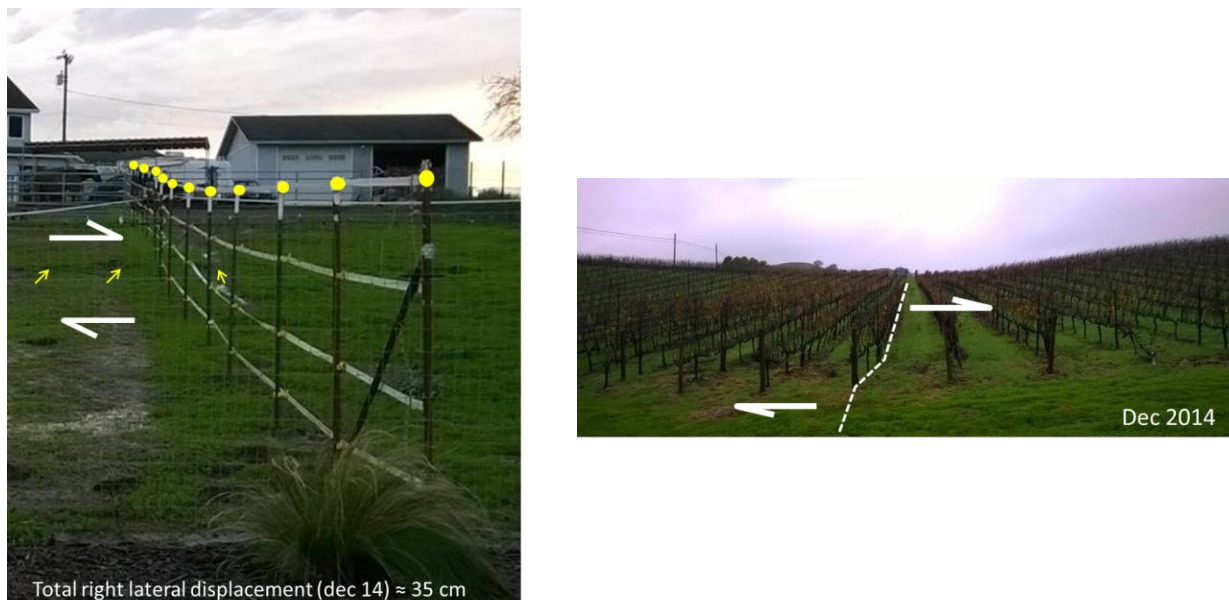
Figure 10: Examples of linear features as markers of right-lateral offset along the main strand (A), as we could observe them in December 2014, 4 months after the quake. Left: a fence is offset of 35 cm south of highway 12 (NAPA 22); yellow arrows underline the fault trace; white arrows the relative displacement. Right: Dextral offset of vine rows south of Browns Valley (NAPA 28).

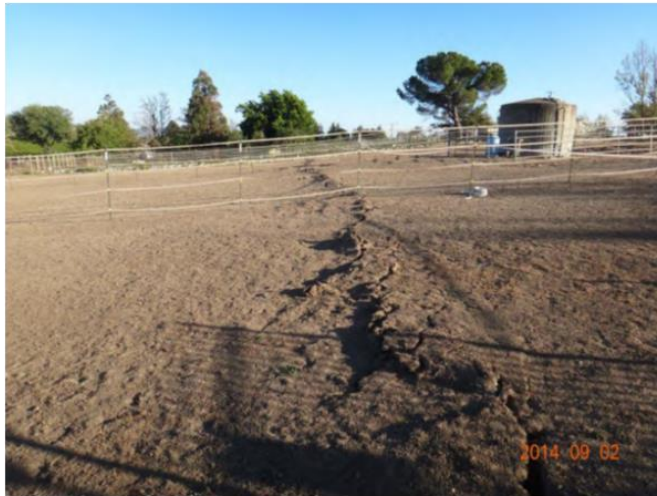
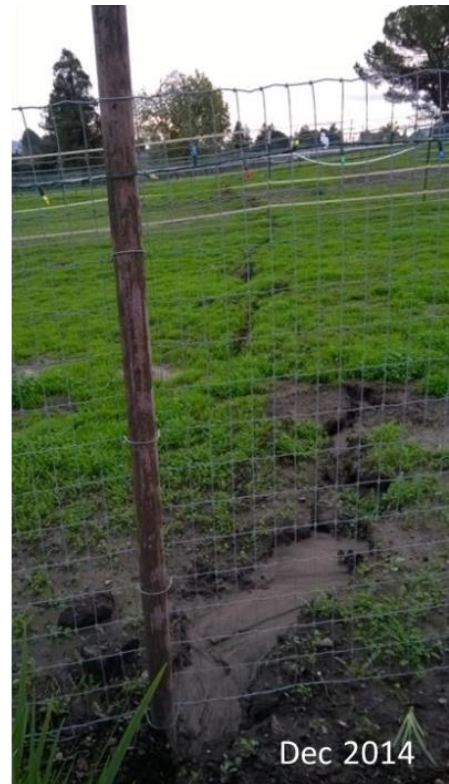
NAPA22; Cuttings Wharf Road, 200 m south of highway 12

Figure 11: Two views of the same fault outcrop at NAPA22 waypoint (offset 32 cm), illustrating the left-stepping fractures.

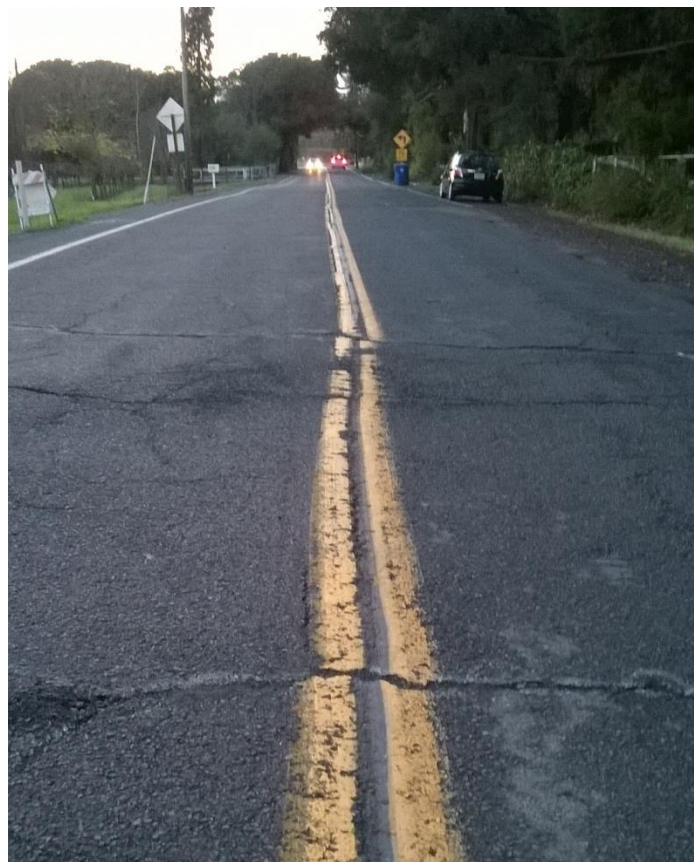
Figure 12: Right-lateral displacement (28 cm) of the Las Amigas road, on the southern section of the 'A' strand, cumulates on several parallel segments (NAPA18). At this place, afterslip is high (more than 90% of the net slip). Picture december 2014.

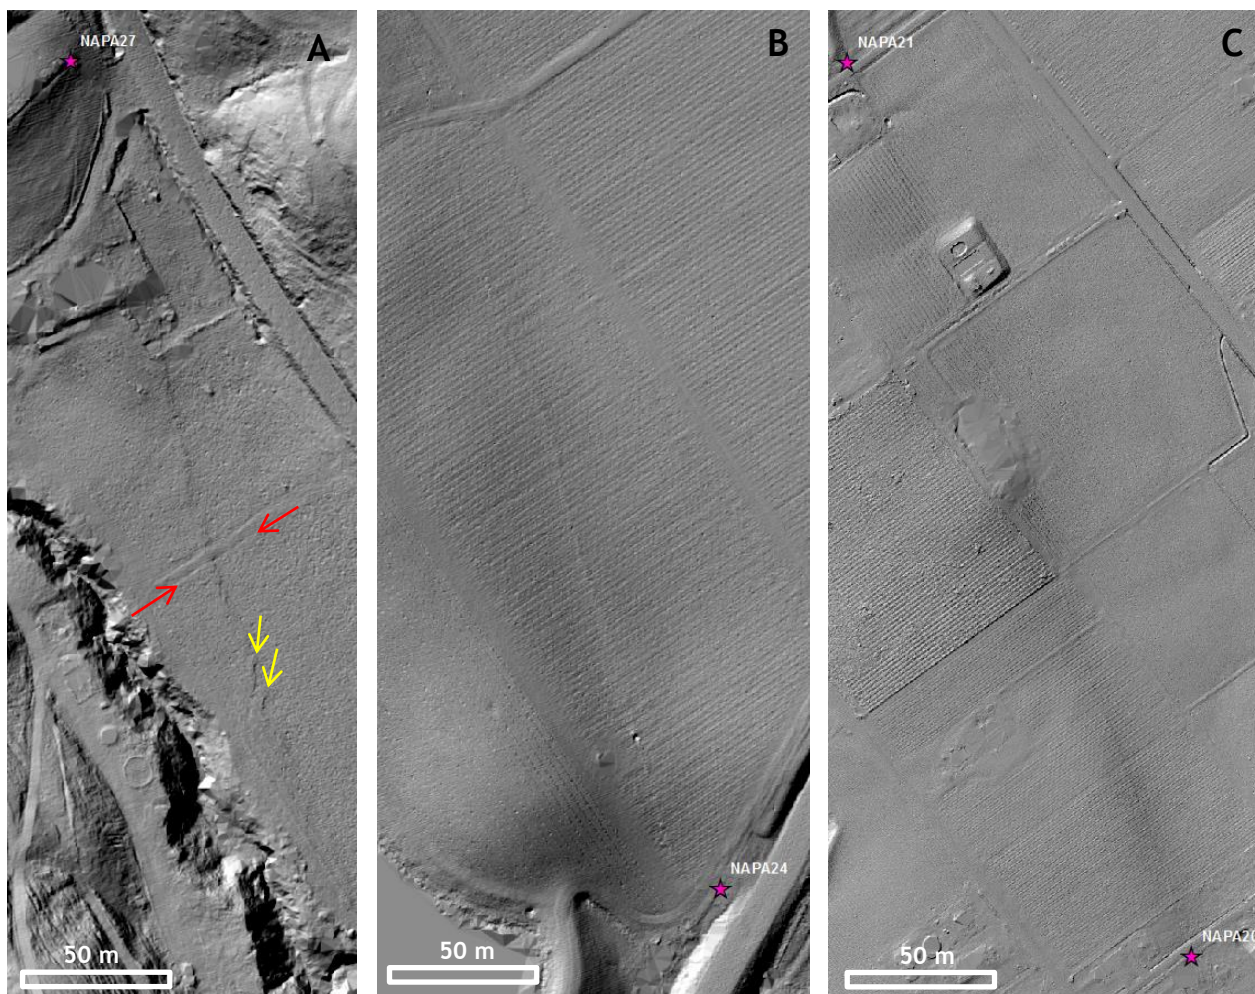
Figure 13: Some outstanding evidences of fault rupture associated with the Napa earthquake as they can be observed on the LIDAR (source: USGS) along the A trace. A: In the northern section, one can observe the left-stepping fractures (yellow arrows) and the dextral offset of the path (red arrow); B: In the middle section, the fault rupture cuts the vine rows where we could measure a 30 cm dextral displacement of a fence (NAPA24 waypoint); C: Along southern section of the rupture, south of Highway 12, the rupture coincides with a gentle scarp facing to the east (underlined by hillshading).

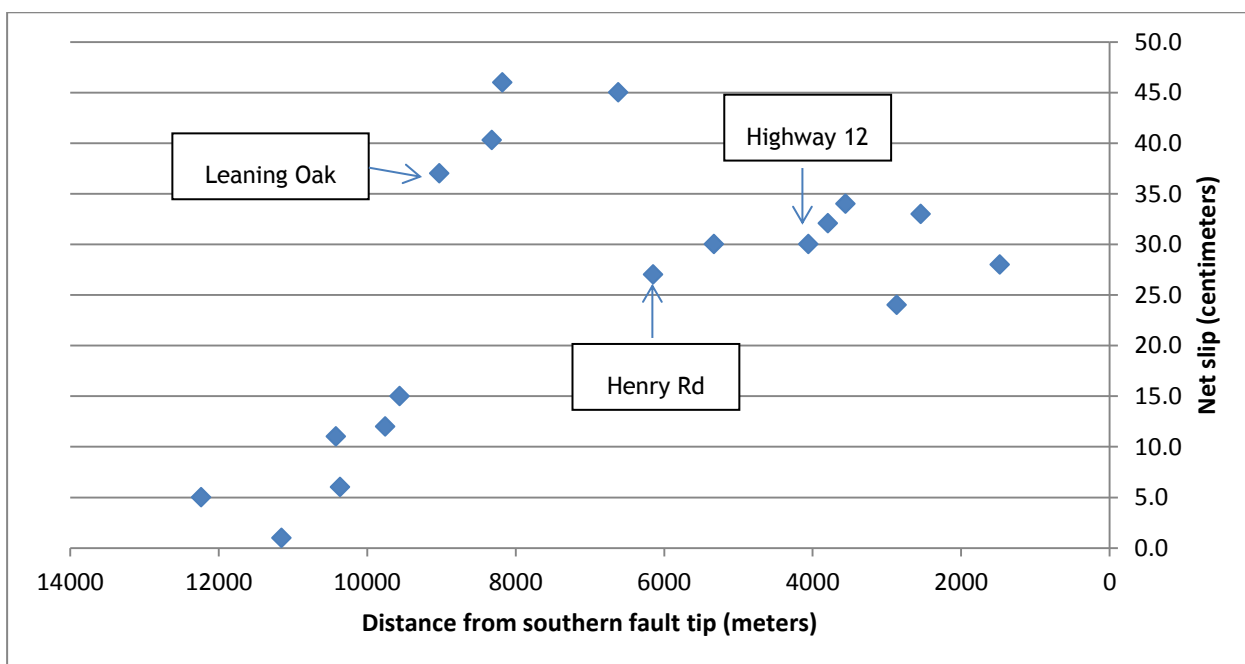
Figure 14 : Distribution of surface slip along the main fault trace, aggregating data from various sources and integrating displacement over several months.

Our data compilation is graphically reported in Figure 14 for the main strand A (main strand). Along this trace, the offset values are reported along the **12.5 km-surface rupture length**, starting from the southern tip. Along this A trace, the **maximum displacement** was measured between Leaning Oak and Henry Road at **46 cm** (i.e. between NAPA 26 and NAPA 29), 8 km north of the southern tip and almost 10 km north of the epicenter. Lienkaemper et al. (2014) and Brocher et al. (2015) state that the 2014 slip at this point was essentially coseismic, respectively 45 cm (data updated in November 2014) and 46 cm (paper published in February 2015).

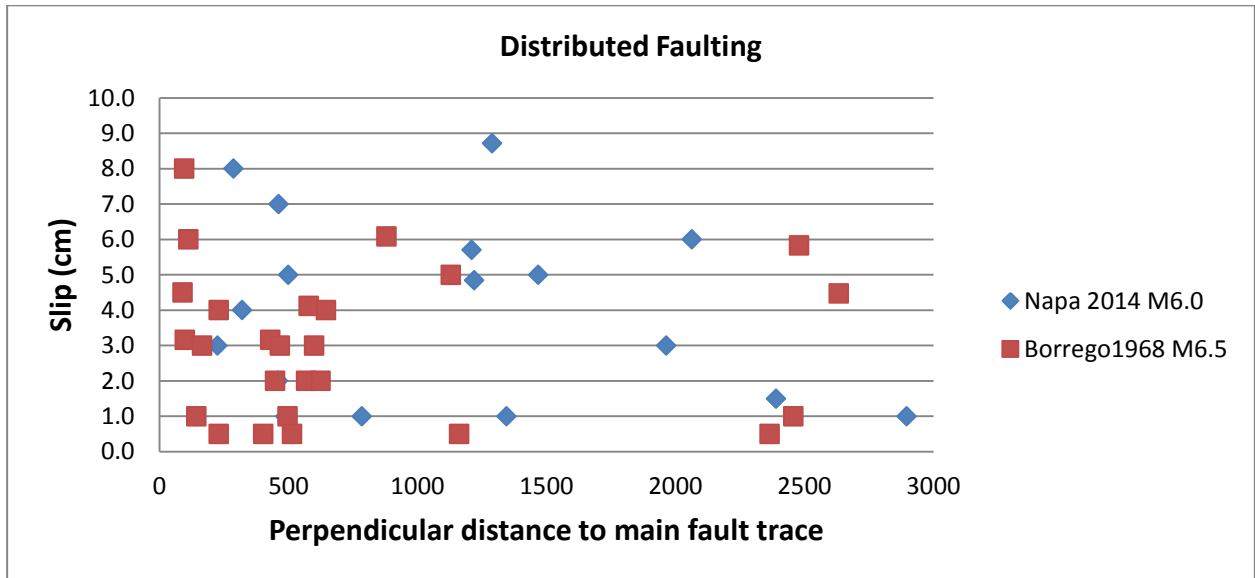
Figure 15 : Distributed slip values compiled from various sources for the Napa earthquake. Values for the M6.5 Borrego Mountain earthquake (Petersen et al. 2011) are also plotted for comparison.

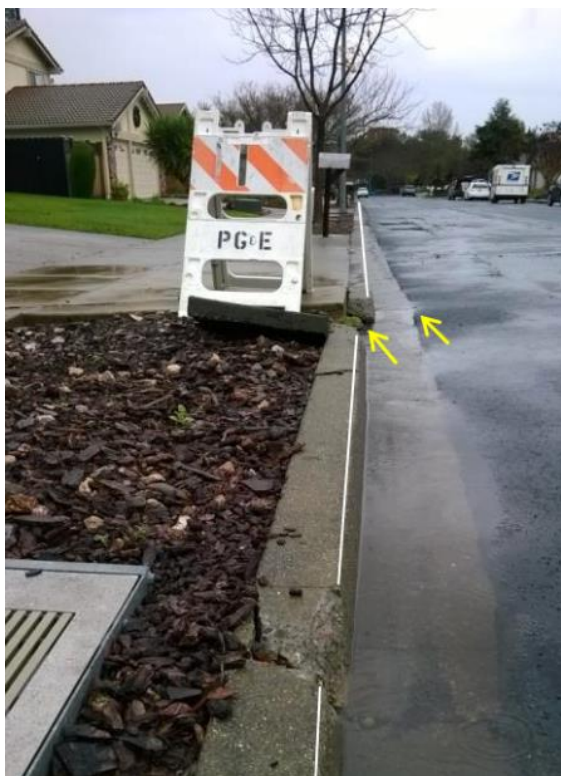
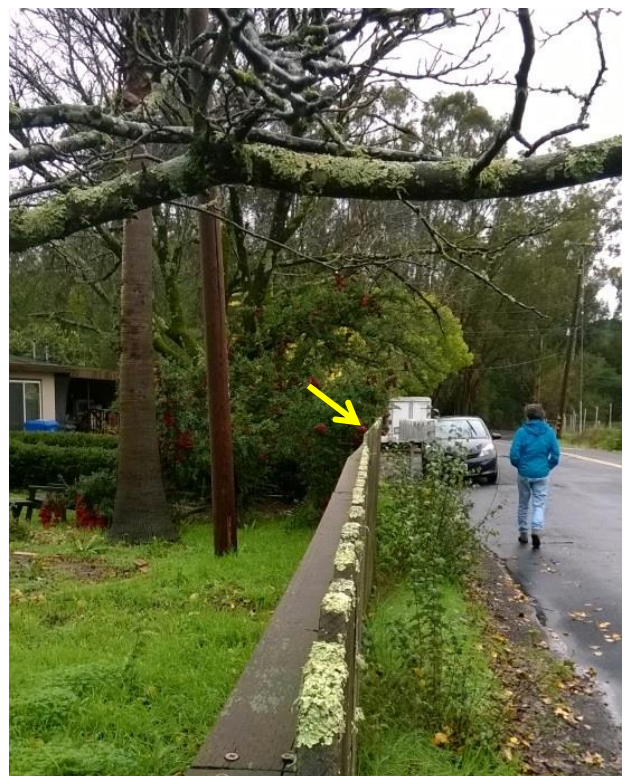
Figure 16: Some evidences of distributed faulting as they could be observed in December 2014 along the C segment. Left: to the north, offset curb in Covey Ct in Browns Valley inhabited area (NAPA6). Right: to the south, displaced fence in Congress Valley Road (NAPA1) (Figure 9).

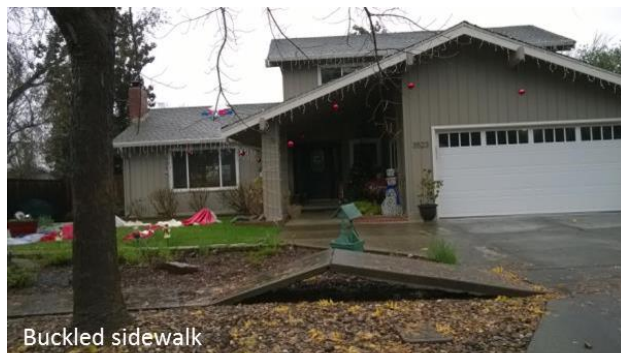
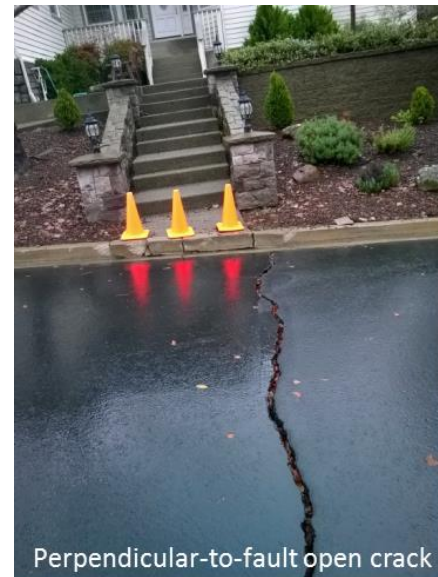
Figure 17: Ground deformation in the vicinity of the fault trace, Browns Valley area (GEER, 2014). Tension evidences include open cracks; compression evidences buckled sidewalks.

In the Browns Valley area, we could observe ground deformations that were not directly associated with surface faulting. Compressional and extensional features, which were revealed by man-made equipment like road pavements and sidewalks, are concentrated over a wide zone west of the surface rupture (segment A). Typical compressional features are buckled sidewalks and extensional are open fractures (Figure 17).

These features were mapped and measured by Bray et al. (2014), who consider them as proofs of tectonic strain. By measuring the pre- and post-lengths, they could determine a weak shortening of about 0.01-0.02% all over the area, both in N-S and E-W direction.

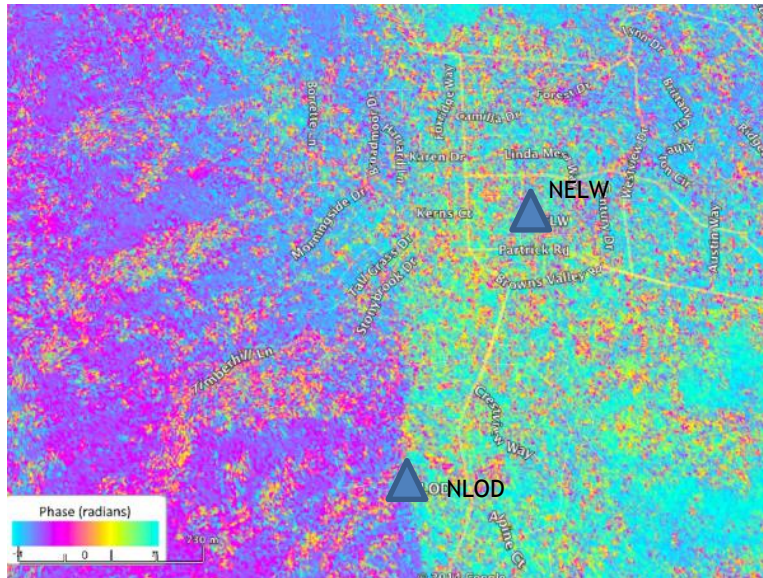
Figure 18: JPL UAVSAR interferogram processed with 2 images shot on the 29/8, five days after the mainshock, and on the 22/10/2014 (Hudnut et al., 2014). Triangles show the positions of monitoring arrays installed by USGS after the earthquake. NLOD: Leaning Oak alignment array (close to NAPA29) and NELW: Ellen Way alignment array (close to NAPA6).

main strand between Leaning Oak and Patrick Road (more or less the one in the imprint of Figure 18) may experience 5 to 15 cm of afterslip in the next 3 years.

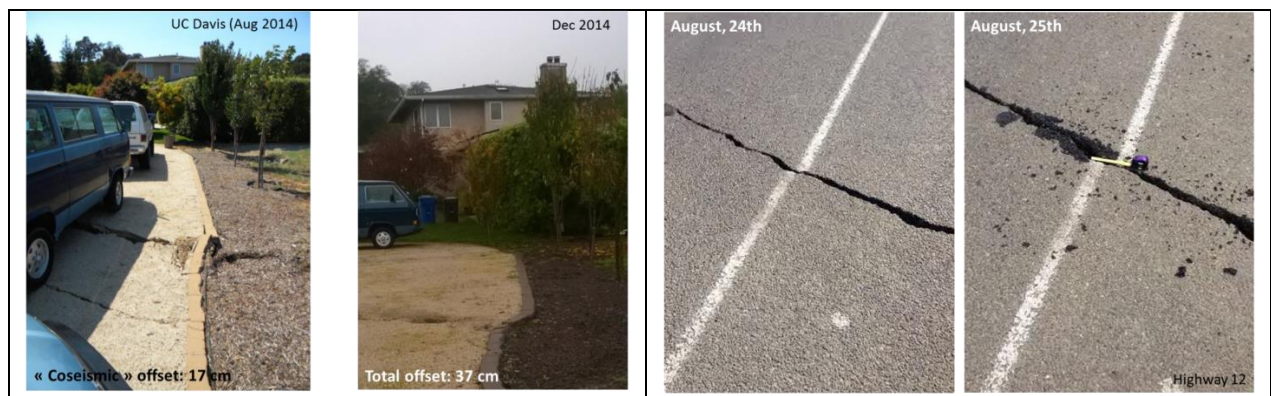
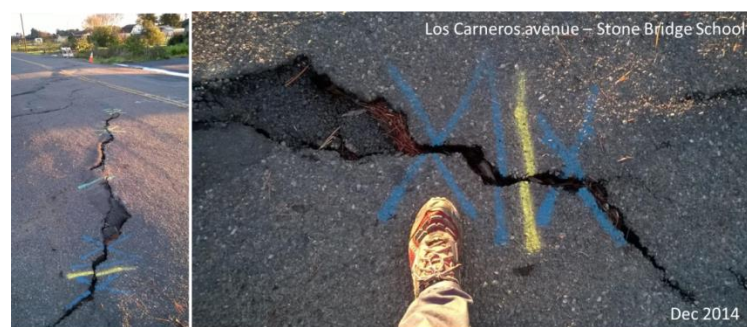
Figure 19: Field evidences of afterslip along the main trace. Top: Leaning Oak (NAPA29), northern section of main segment (left picture from UC Davis); Middle: Highway 12 (picture from Bray et al., 2014, GEER report), southern section of the main segment (NAPA23); bottom: Los Carneros avenue, southernmost part of this segment (NAPA19); blue and yellow lines were drawn on the fault rupture in the first hours after the mainshock and their later offset illustrates the postseismic slip (afterslip).

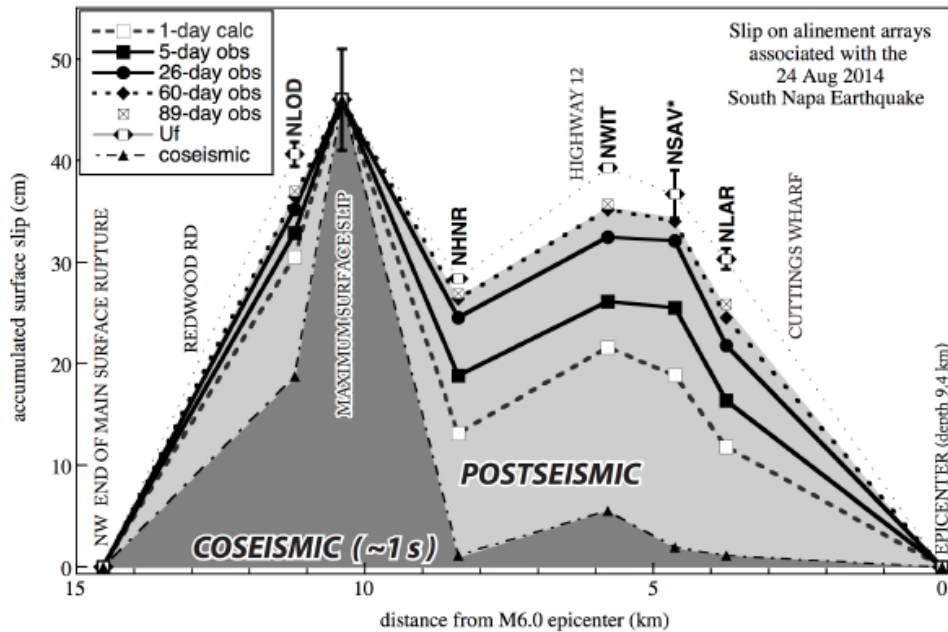
Figure 20: Evolution in space and time of afterslip at the earth surface (from Lienkaemper et al., 2014, in Hudnut et al., 2014). Epicenter (south) is at right; Browns Valley (north) is at left, between 11 and 13 km. Coseismic slip amount could not be measured, thus is estimated from seismological data. Afterslip is then reported according to alignment array data and it increases with time (between 5 and 89 days). Uf is the forecast total final displacement.

As suspected from successive field observations through time, the alignment array measurements confirm that afterslip was very large in the first hours and days and then steadily slowed down (Figure 20). Fifty percent of the afterslip occurred after 1 day, 75% after 5 days and most of the afterslip was done after 60 days. The AFTER model forecasts that in the long-term afterslip can however last for years. Thus, in the populated Browns Valley area, the

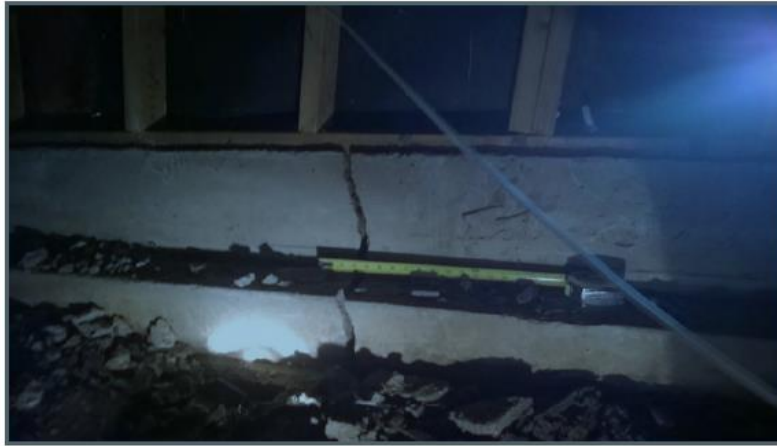
Figure 21 : Example of a strip footing foundation displaced by faulting (picture from Bray et al., 2014)

The Browns Valley area, in which facilities are dominantly single-family residences consisting of single-story wood-frame structures, was extensively affected by surface faulting. The GEER field teams examined ~40 structures in 3 days and, although the houses were damaged during shaking, the engineers could discriminate the effects of faulting. They could observe new open cracks going through the structures or concrete slabs, horizontal or vertical displacements of walls or foundations (e.g. Figure 21), offsets of curbs, displacements of structures away from the adjacent ground or from their foundations, etc. In some houses with pier-and-grade beam foundations, relative displacement due to faulting provoked torsion and cracking of walls. In December 2014, we could still observe damages and restoration works in progress, like red-tagged houses located on the main fault that necessitate complete reworking of their foundations (Figure 22): the technique is to “uplift” the house, in order to keep its integrity, and repair the foundation damage. In the neighborhood of the illustrated case, around 10-15 cm surface displacement was measured. In December 2014, we could even observe a house with damaged foundation on the secondary segment C, where offset was around 5 cm (Figure 23).

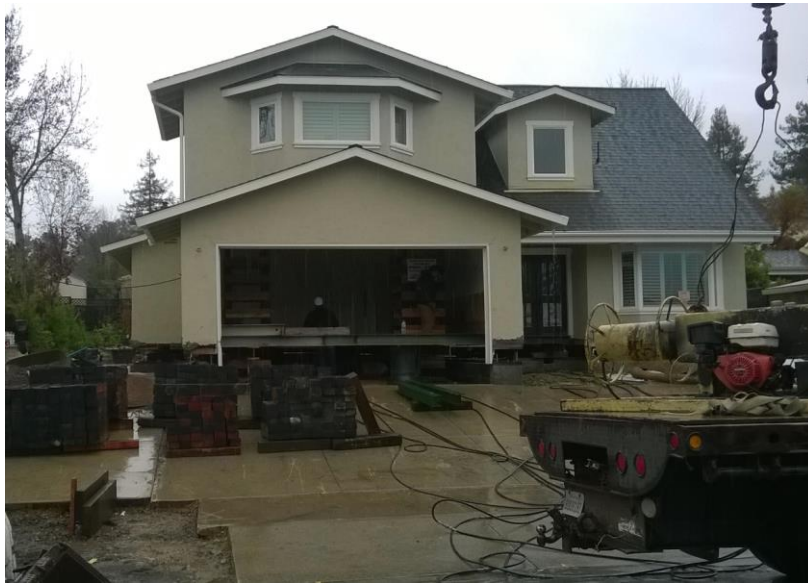
Figure 22 : Work in progress on a residence foundation affected by faulting, located on the primary fault trace A (close to NAPA30 waypoint, White Cliff Circle). The house has been uplifted for the repairing. Surface slip was measured to be around 10-15 cm.

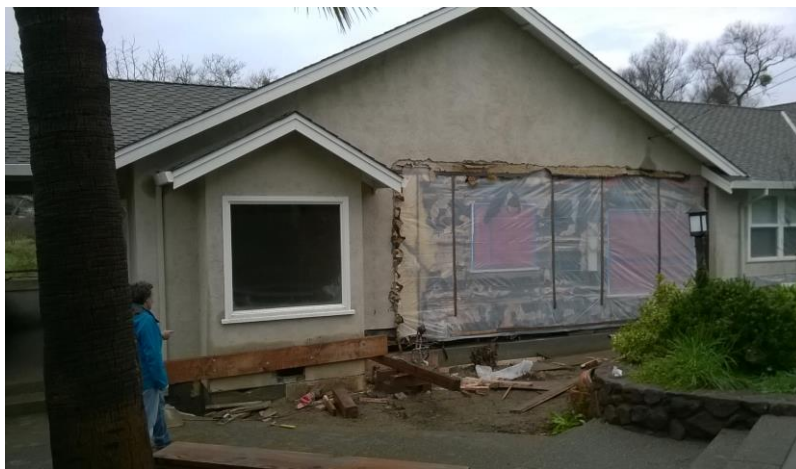
Figure 23 : Work in progress on a residence foundation affected by faulting, located on the secondary (distributed) fault trace C (close to NAPA2 waypoint). The wall has been destroyed by workers after the earthquake. A 5-6 cm Surface slip was measured on the close road pavement just after the earthquake.

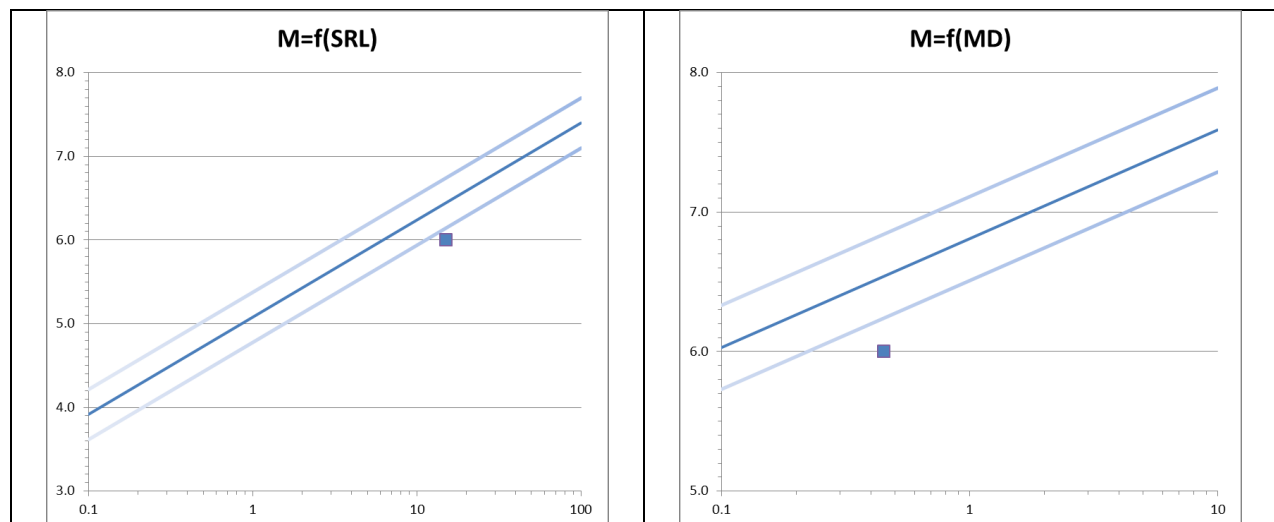
Figure 24: Napa Earthquake values of Surface Rupture Length (SRL, left) and Maximum Displacement (MD, right) plotted against a ‘Wells and Coppersmith’ mean correlation with magnitude, including standard deviation.

When compared to regional (California) data of similar magnitude historical events (since 1948), the 2014 earthquake is largely above the mean values for maximum displacement (MD) and surface rupture length (SRL) which are 6.5 cm and 5 km respectively (Brocher et al., 2015). Also, when compared to a worldwide dataset of strike-slip earthquakes that can be represented by the relevant Wells and Coppersmith (1994) regressions, the Napa earthquake falls outside the mean and standard deviation values (Figure 24).

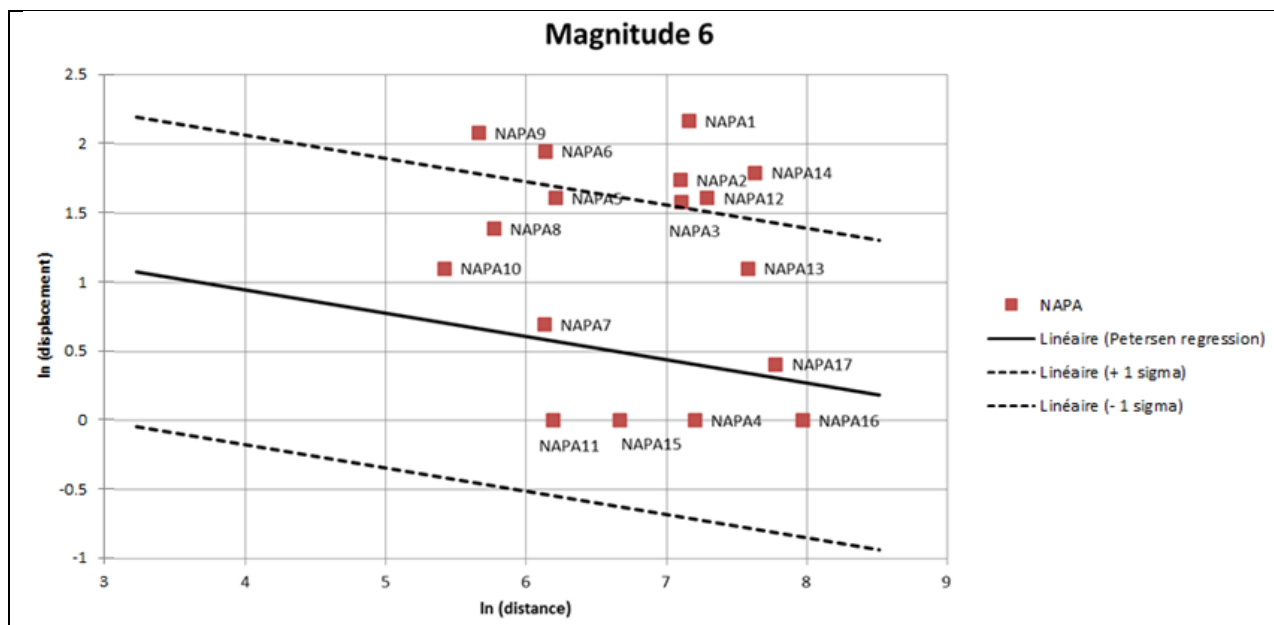
Figure 25: Graph illustrating the Napa secondary ruptures measurements with respect to the predictive regression of an M=6 event (Petersen et al., 2011). For location of measurement points, refer to Figure 9.

This regression has been calibrated with a limited dataset of seven strike-slip earthquakes that occurred in California, greater than magnitude 6.5. This regression is extrapolated in recent studies for nuclear power plant safety down to magnitudes 5.0 and 6.0, respectively for Krško NPP in Slovenia (Rizzo, 2013) and for Diablo Canyon NPP in California (NRC, 2012). Taking into account the values measured after the Napa earthquake on secondary segments, we think that the Petersen regression and its uncertainties could be updated. Indeed, some measured displacements of the Napa dataset fall out of the expected uncertainty range, with a higher mean value (Figure 25).
