HELLENIC REPUBLIC  
National and Kapodistrian  
University of Athens

Environmental, Disaster and  
Crisis Management Strategies

# **LESVOS EARTHQUAKE Mw 6.3, JUNE 12, 2017**

## **PRELIMINARY REPORT**

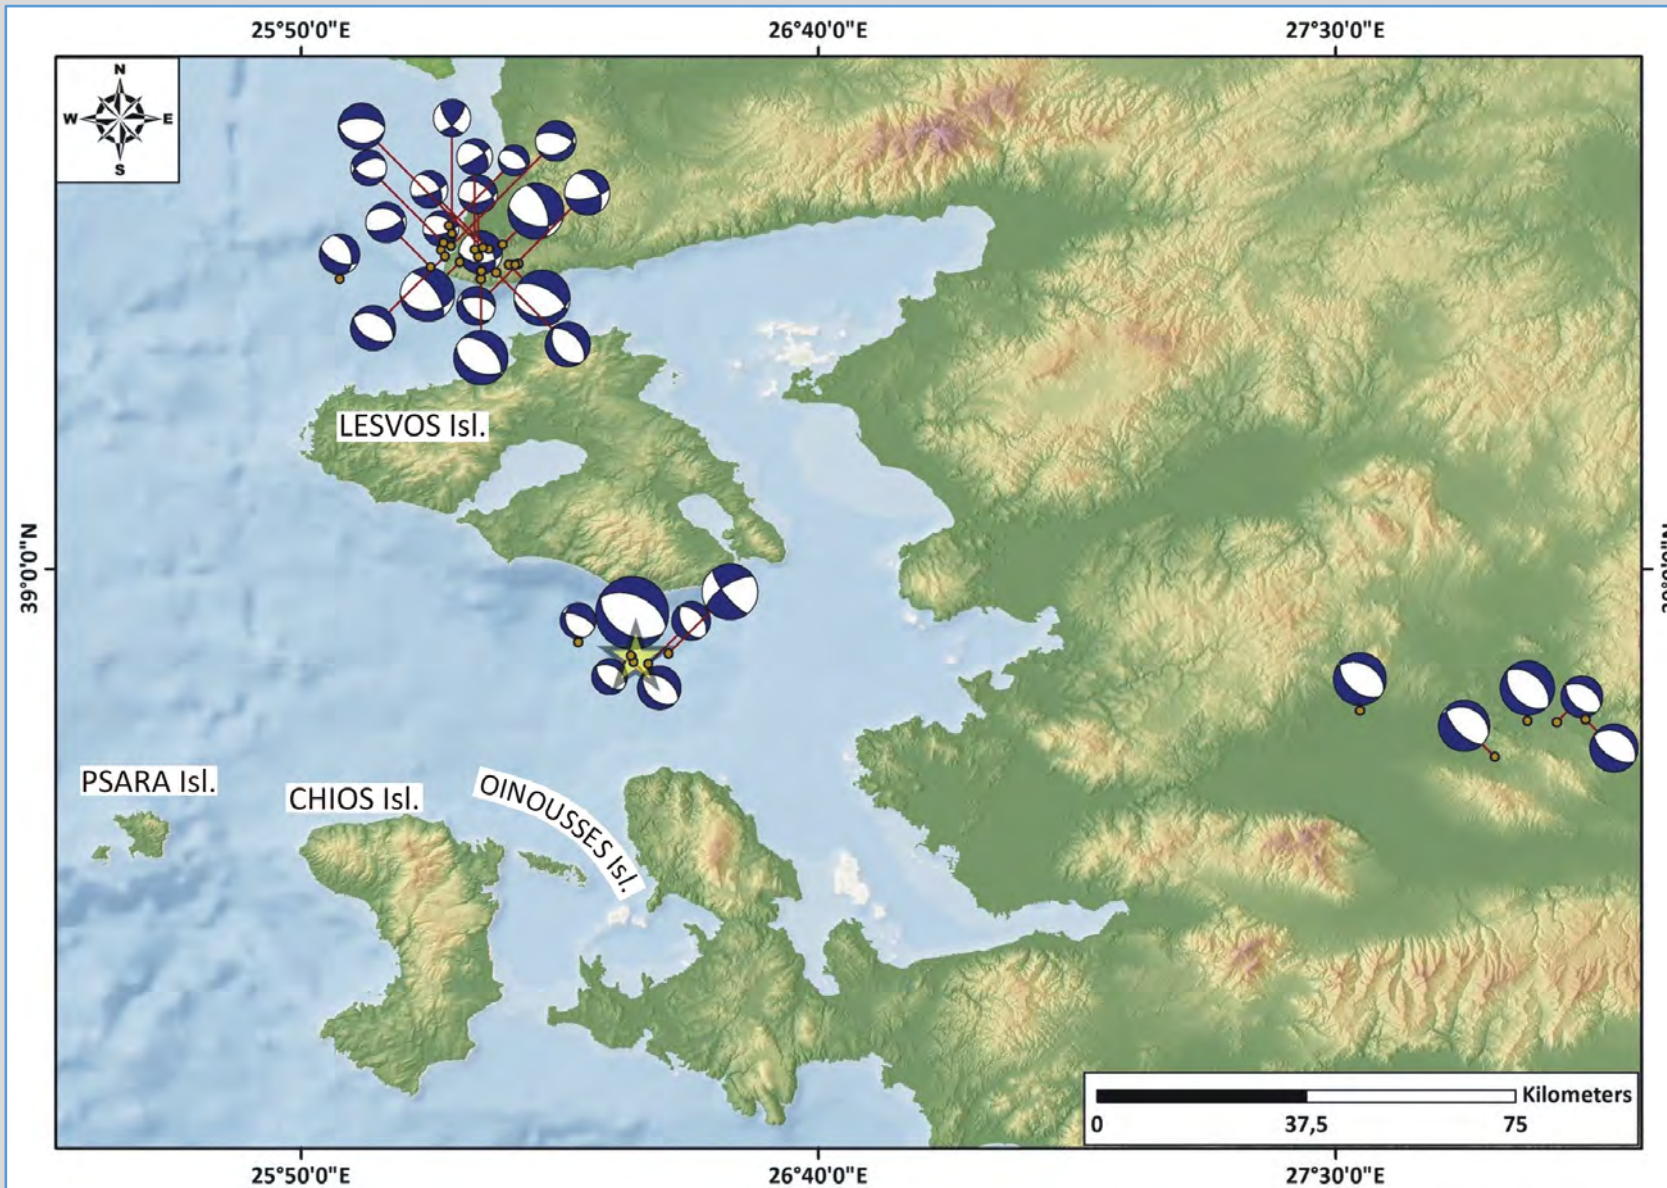
*The provided focal mechanisms indicated that the earthquake was generated by a normal fault located offshore southeastern Lesvos*

The spatial distribution of aftershocks showed a NW-SE direction, which coincides with the direction of a 25-30km seismogenic fault.

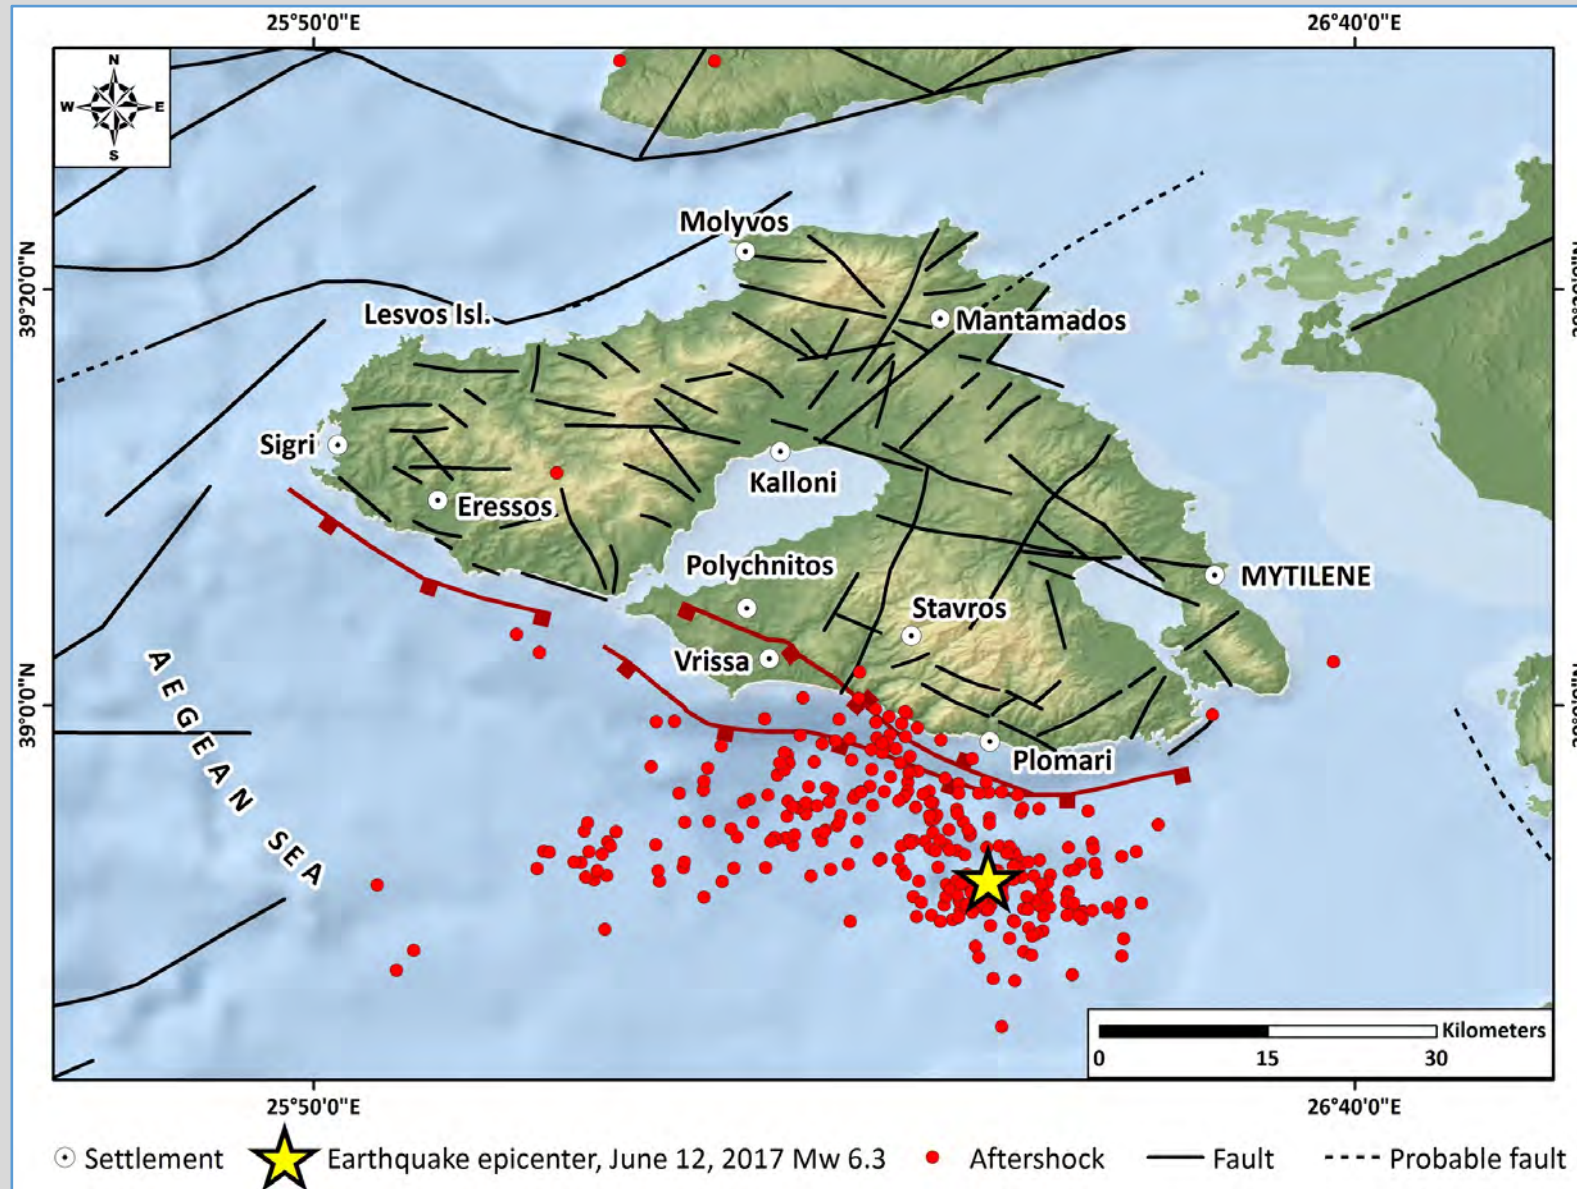
### The aftershocks of the June 12 2017 Mw 6.3 and active faults

The spatial distribution of aftershocks showed a NW-SE direction, which coincides with the direction of a 25-30km seismogenic fault.

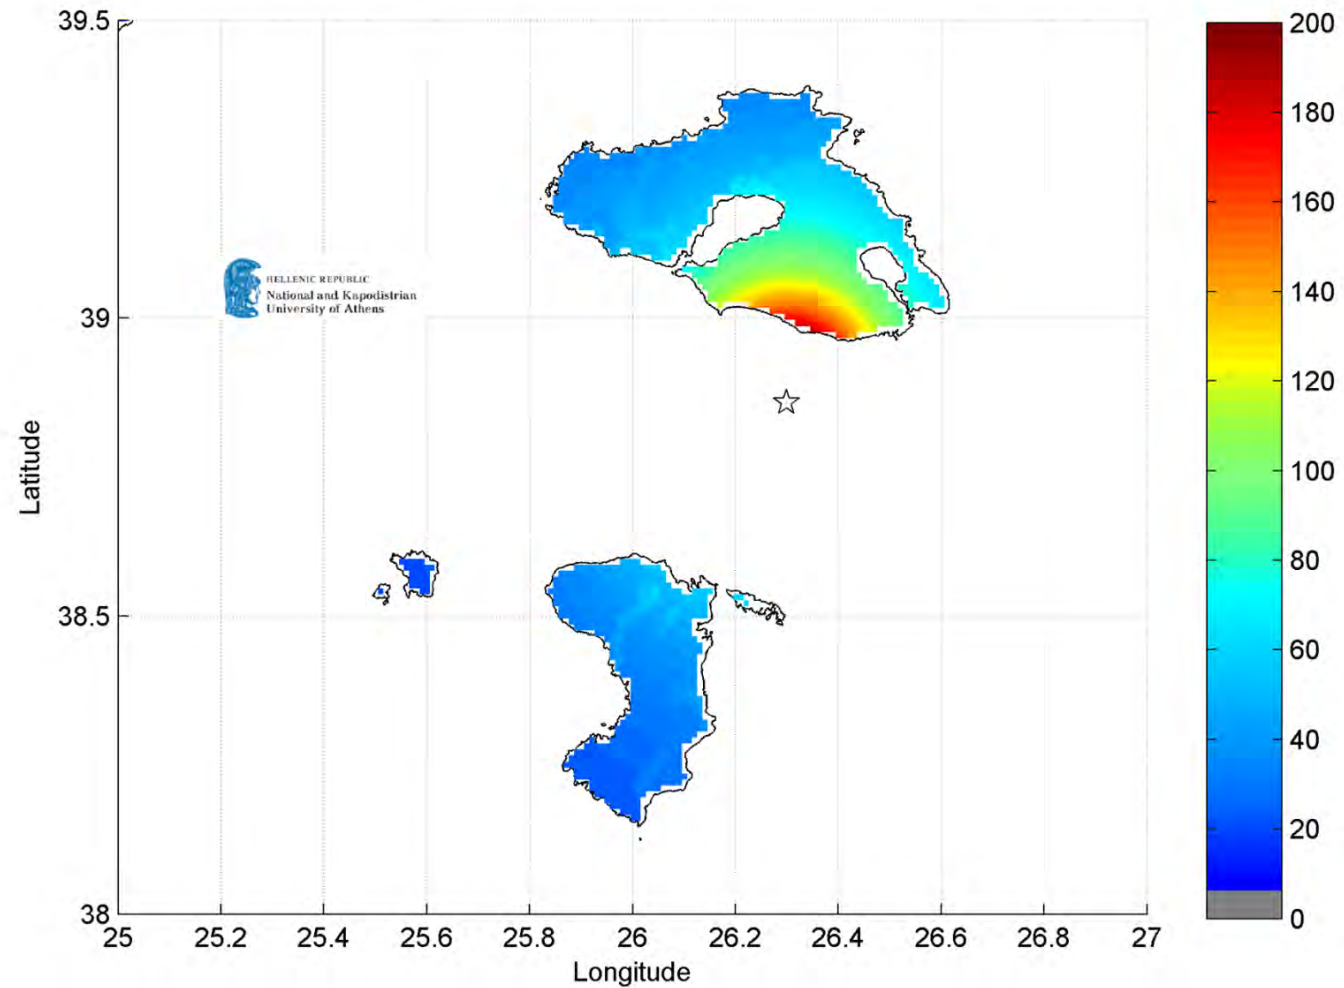
*Peak Ground Acceleration Map*

12-Jun-2017 12 28 38 GMT Mitilini M 6.3  
University of Athens, Seismological Laboratory Automatic PGA ( $\text{cm/s}^2$ ) distribution

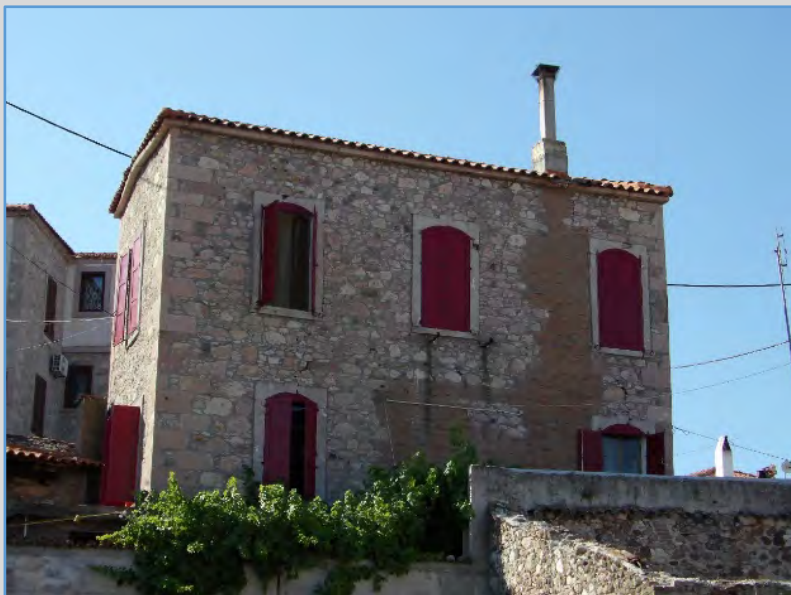
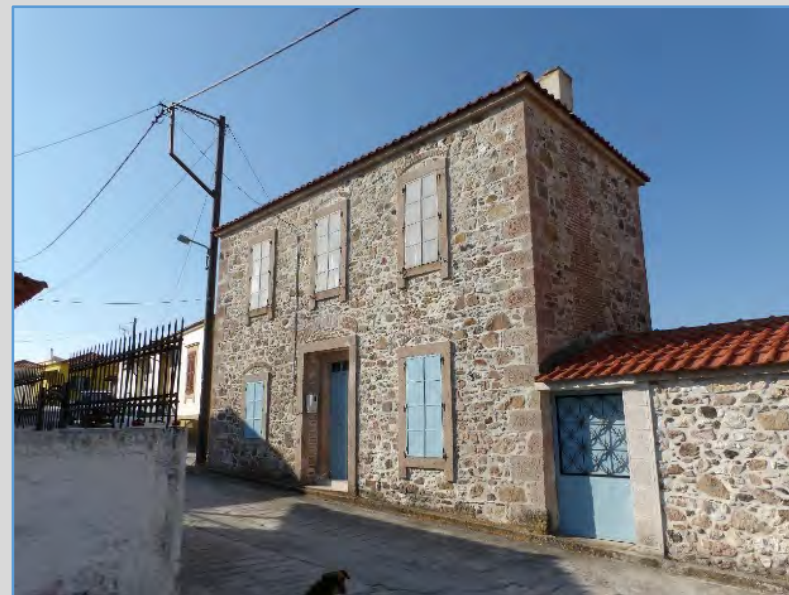
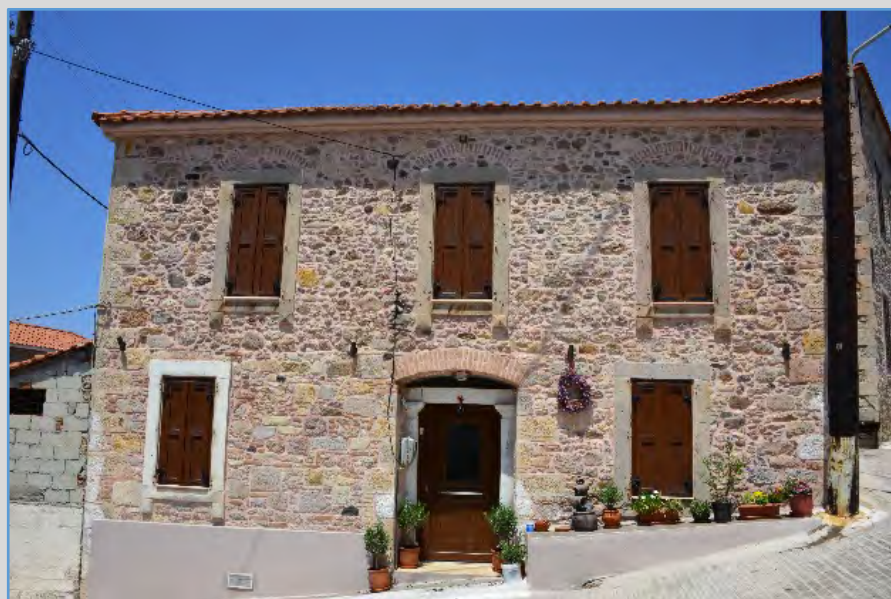
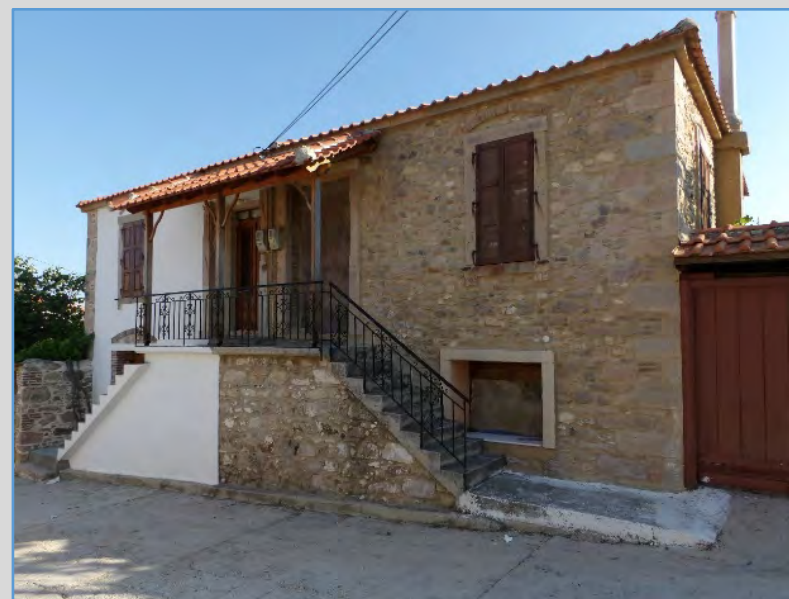
*Typical structures with masonry load-bearing walls that remained intact*

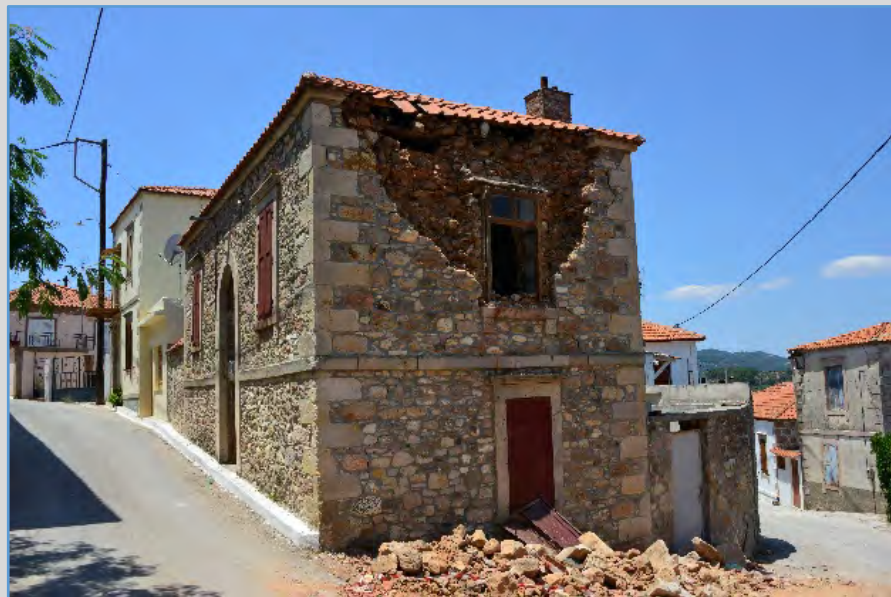
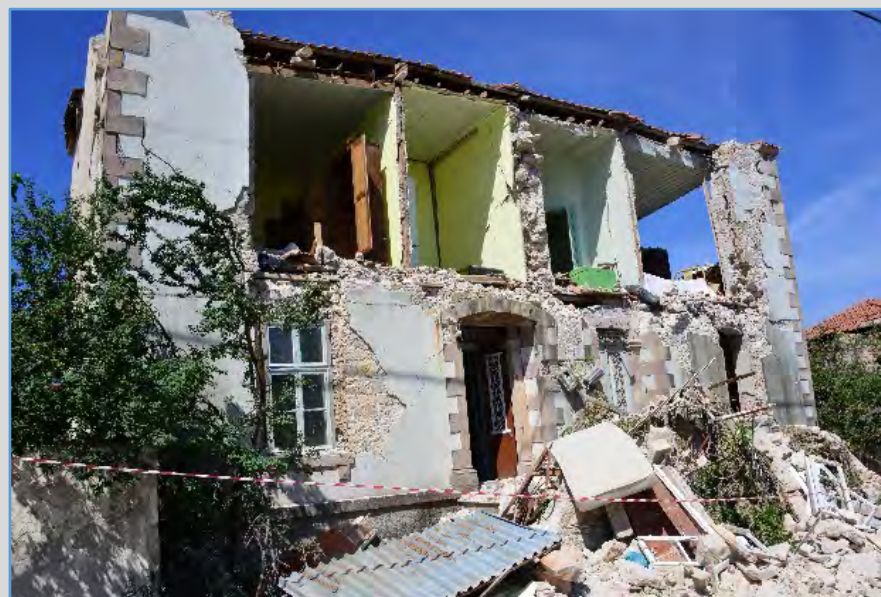
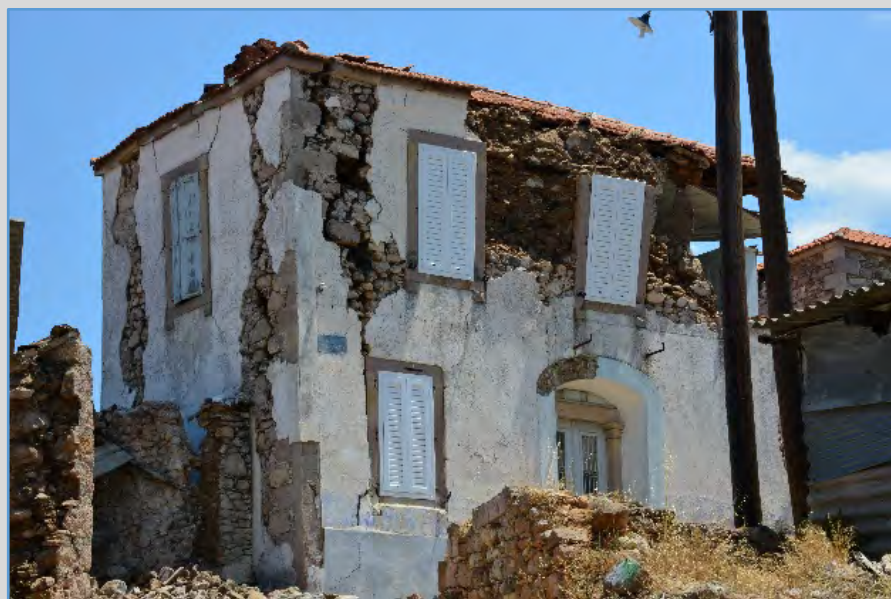
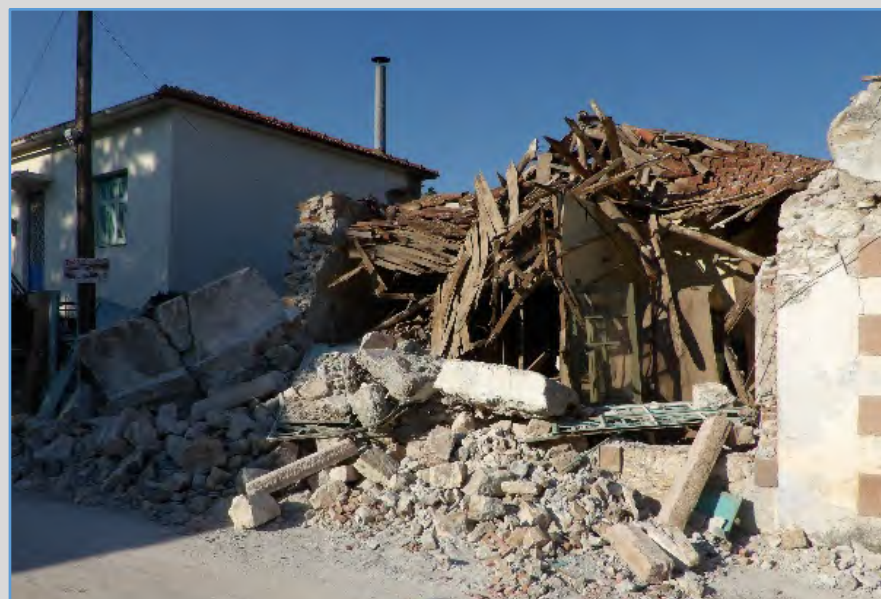
Heaviest damage was reported in the village of Vrissa and it was rapidly assessed by using of modern and innovative technologies and methodologies including Unmanned Aerial Vehicles and GIS online applications. About 80% of its buildings, most of them traditional stone masonry residential constructions built by the end of the 19<sup>th</sup> century or the beginning of the 20<sup>th</sup> century were damaged. Several collapsed while many were heavily damaged, reported dangerous and/or unrepairable.

*Damage on structures with load-bearing masonry walls*

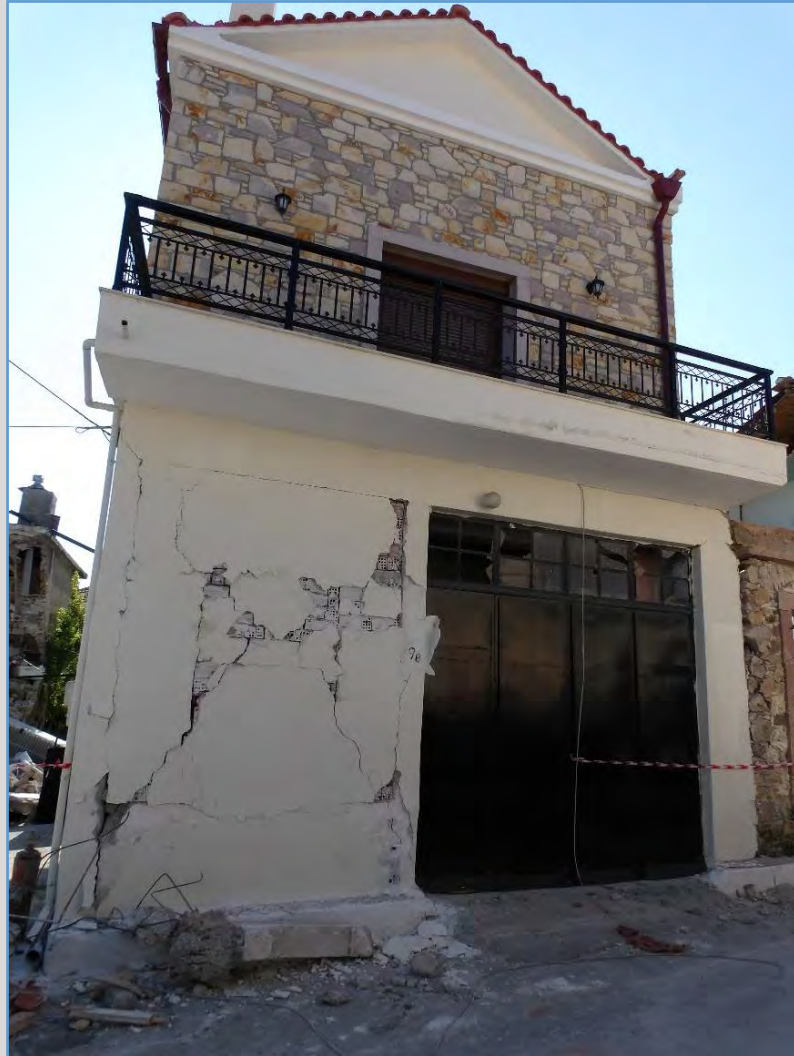
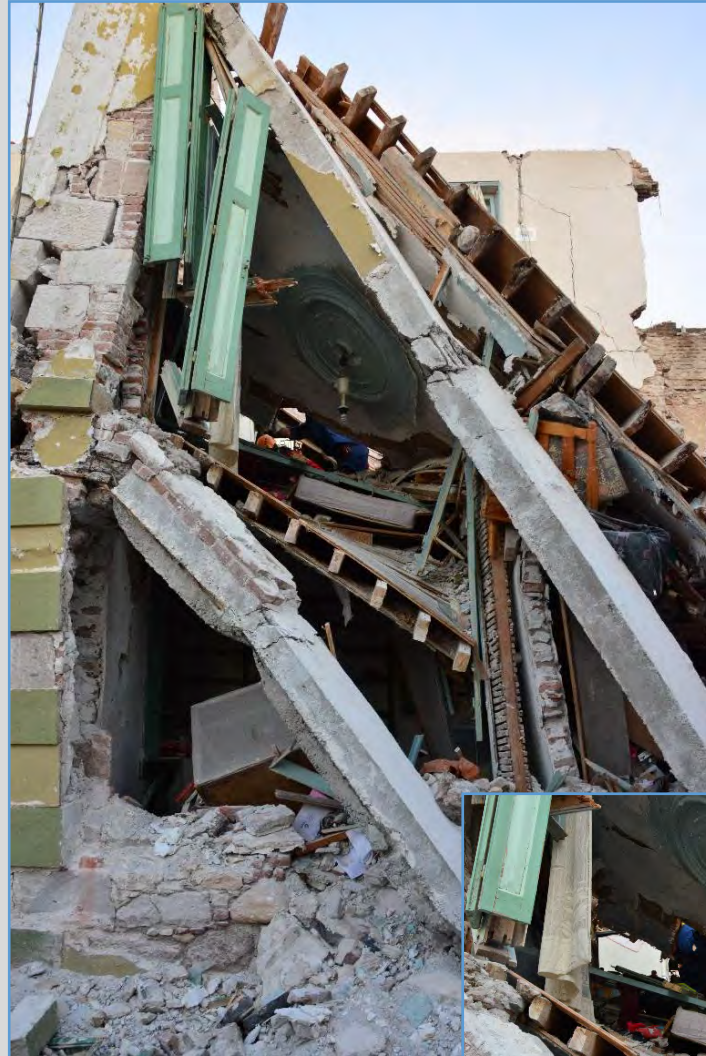
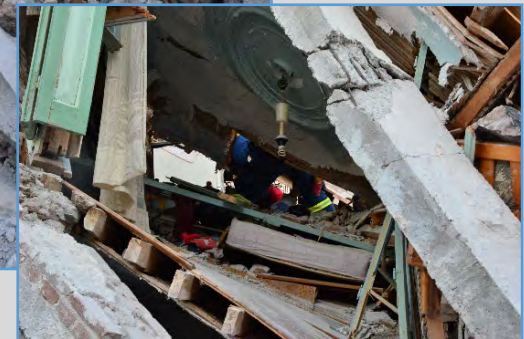
*Reinforced-concrete structures with non-structural and structural damage*

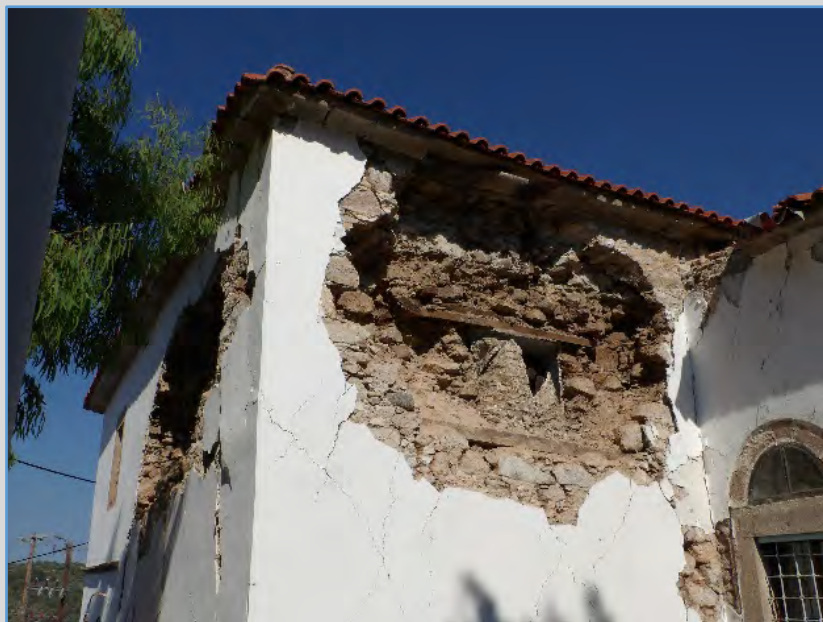
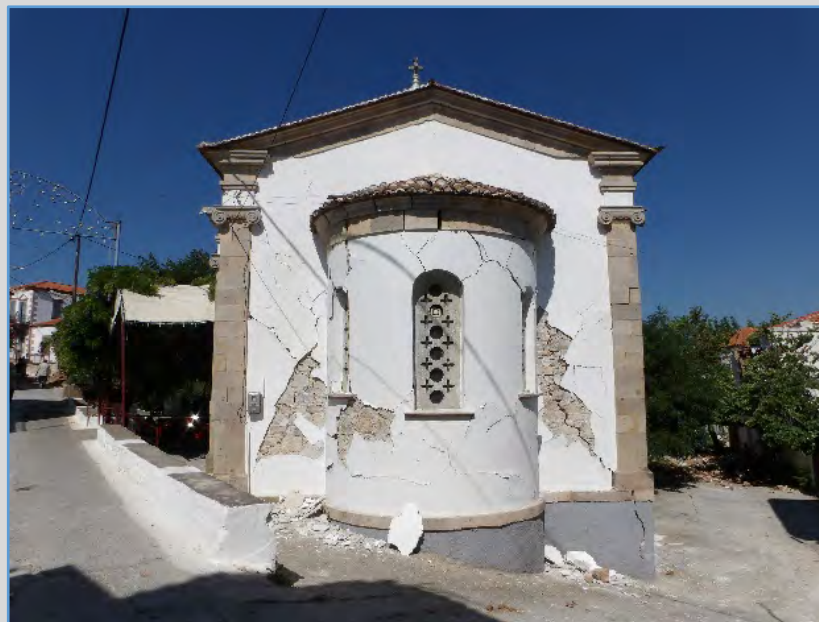
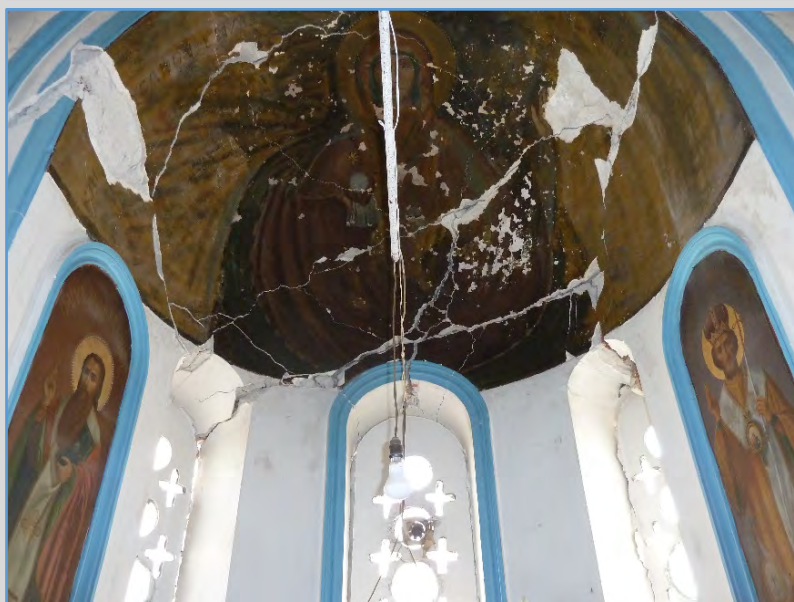
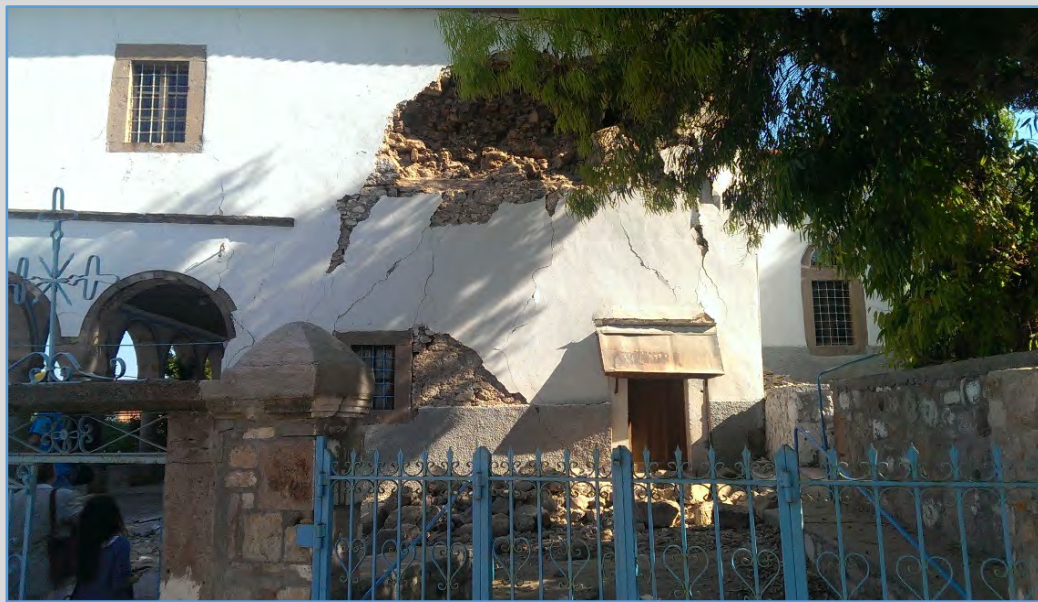
Monumental structures, such as post-Byzantine churches suffered serious static problems immediately after the earthquake. Cracks in the masonry load-bearing walls have been also observed at several old buildings in the historical center of the capital town of Mytilene, located about 35 km NE of the epicenter, including buildings of the University of the Aegean as well as the historical town hall of the city. Old industrial buildings in several villages up to 35km from the epicenter suffered also partial collapse. Limited damage were observed in old buildings with load-bearing walls of Plomari, Polichnitos, Lisvori, Stavros, Akrafi, Palaeochori, Megalochori, Plagia and Agios Isidoros settlements.

*Damage on Monumental masonry structures*

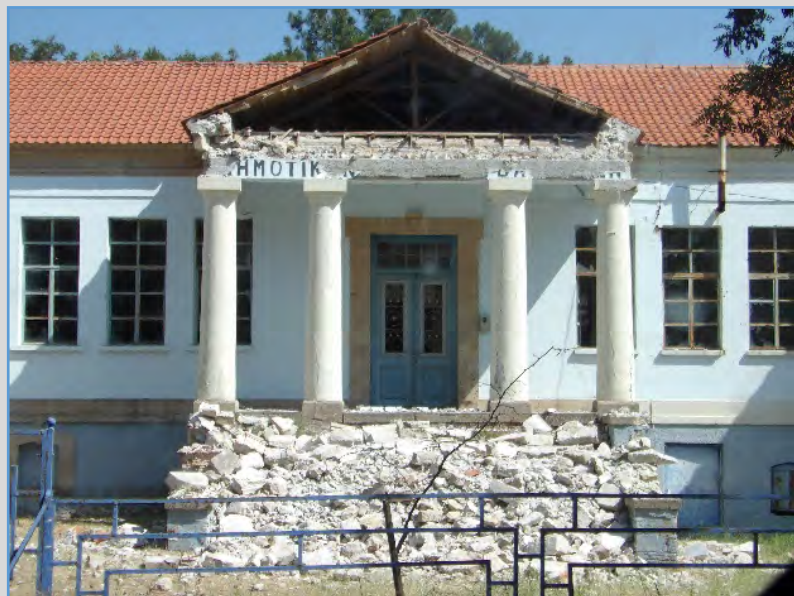
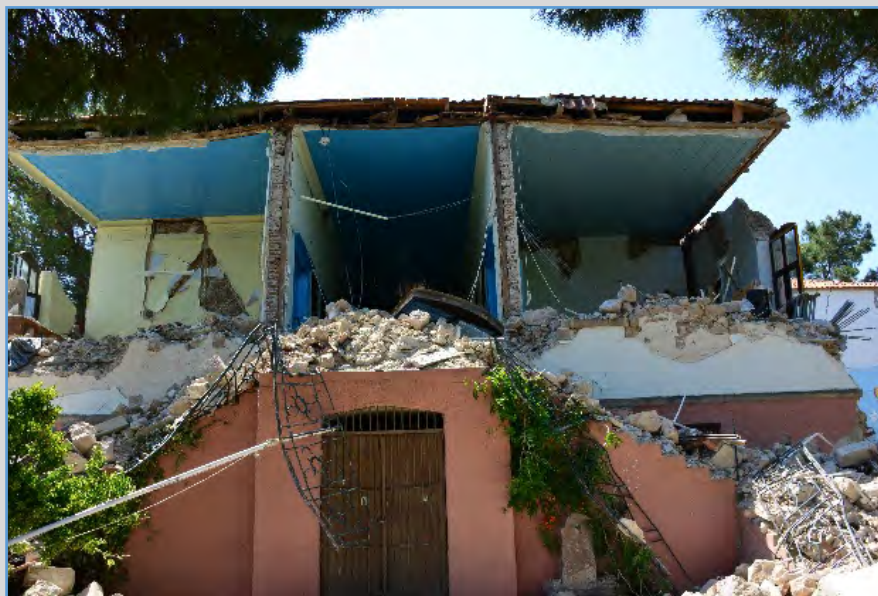
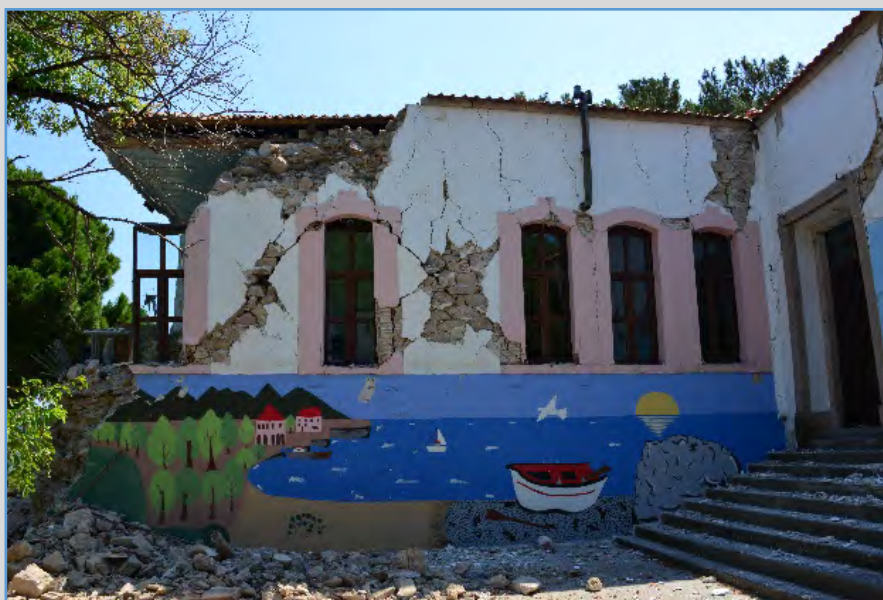
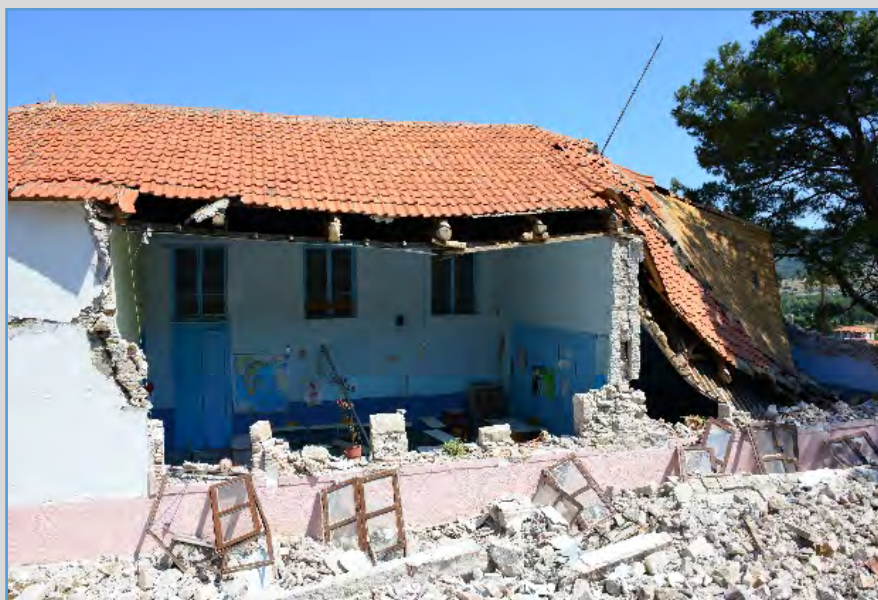
### *Damage on schools*

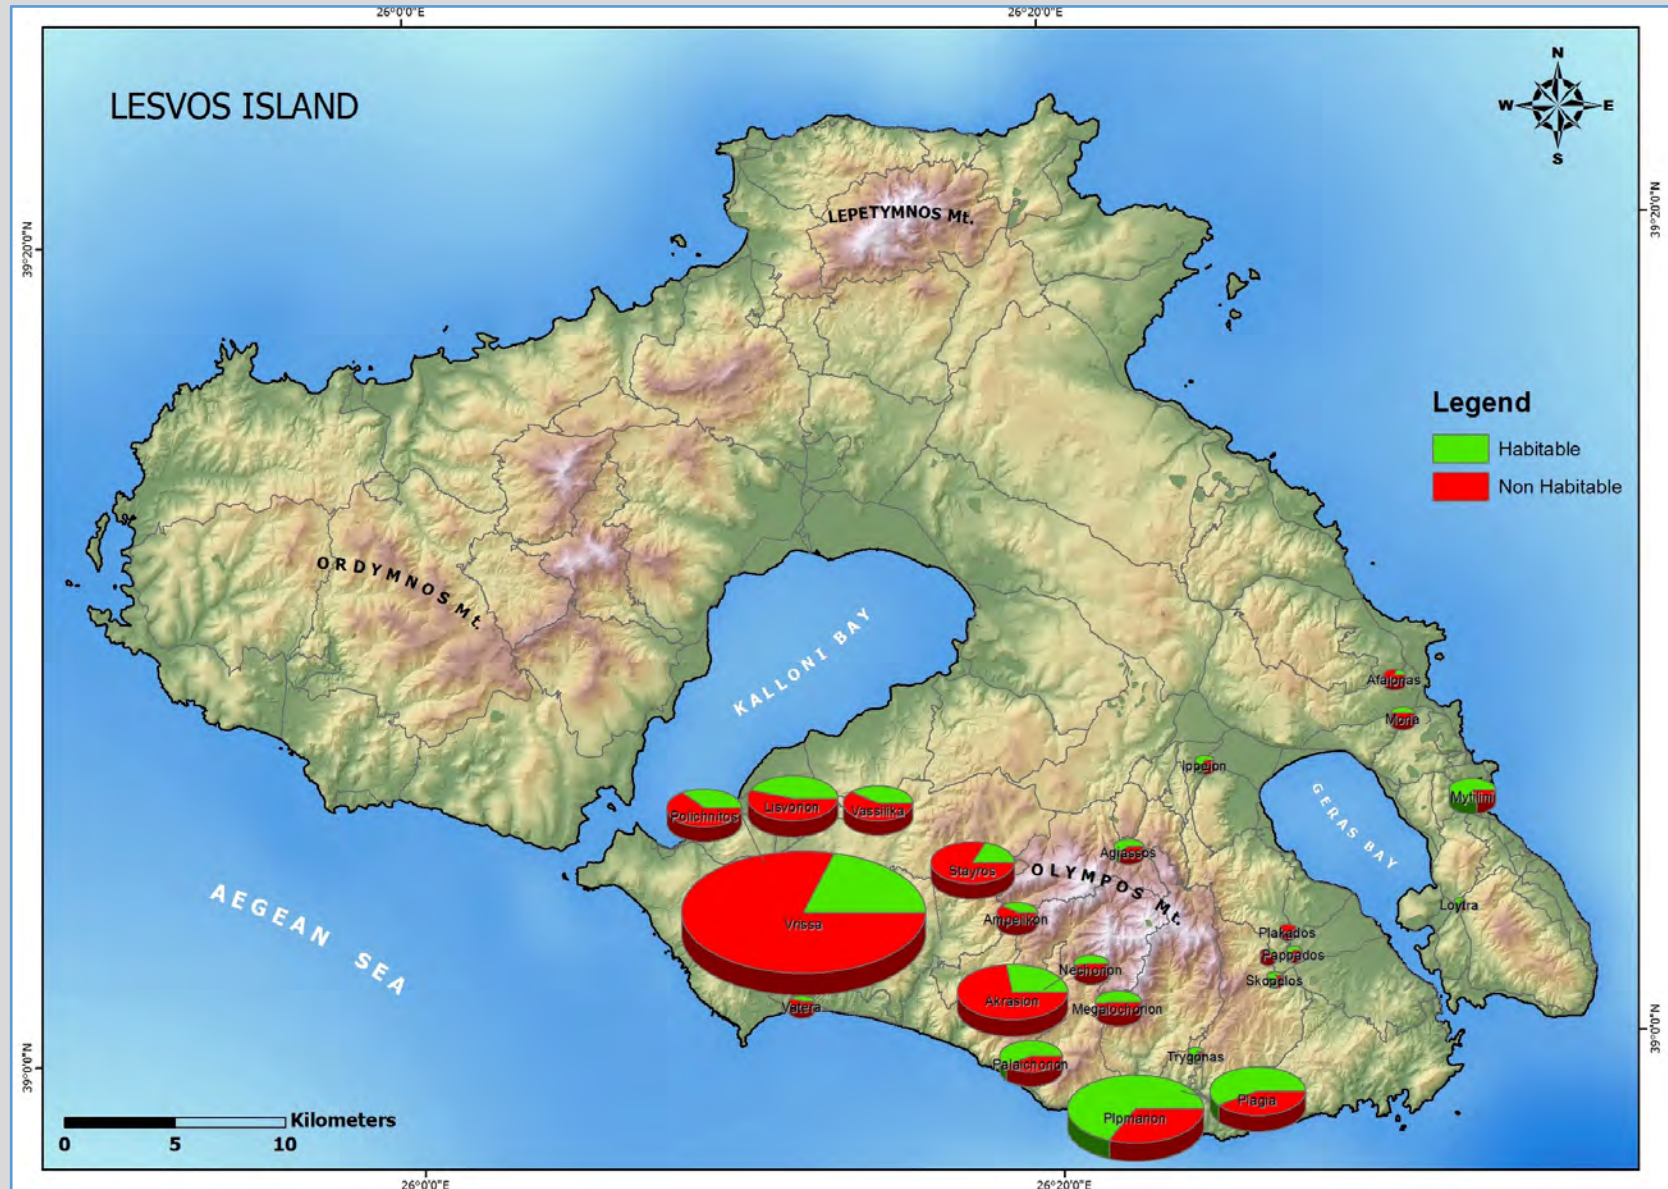
# Percentage of damage per settlement

Damage was widespread throughout the southeastern part of Lesvos (damage is reported in at least 12 villages) whereas effects have been also observed at the Turkish coast. Based on the final list of the first round of buildings' formal inspections of 1986 buildings, 871 were found safe and 1115 unsafe for use.

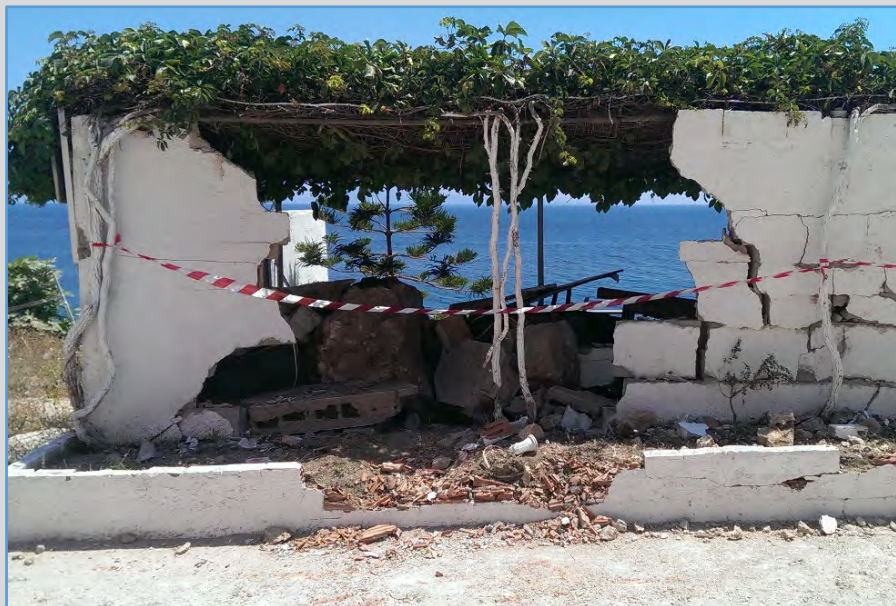
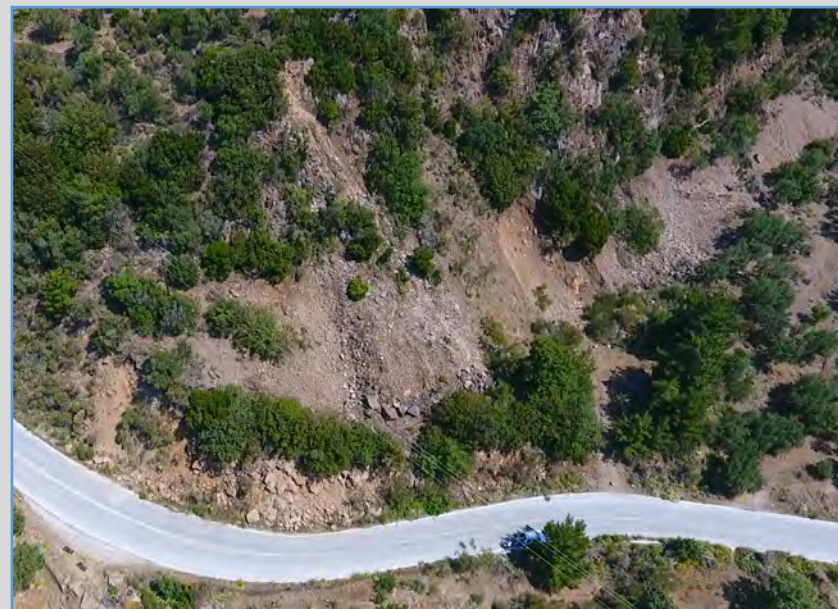
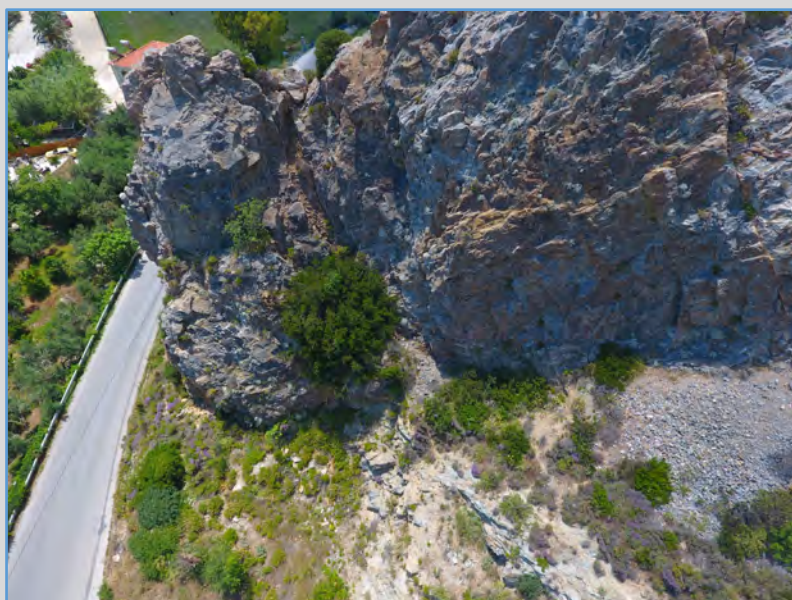
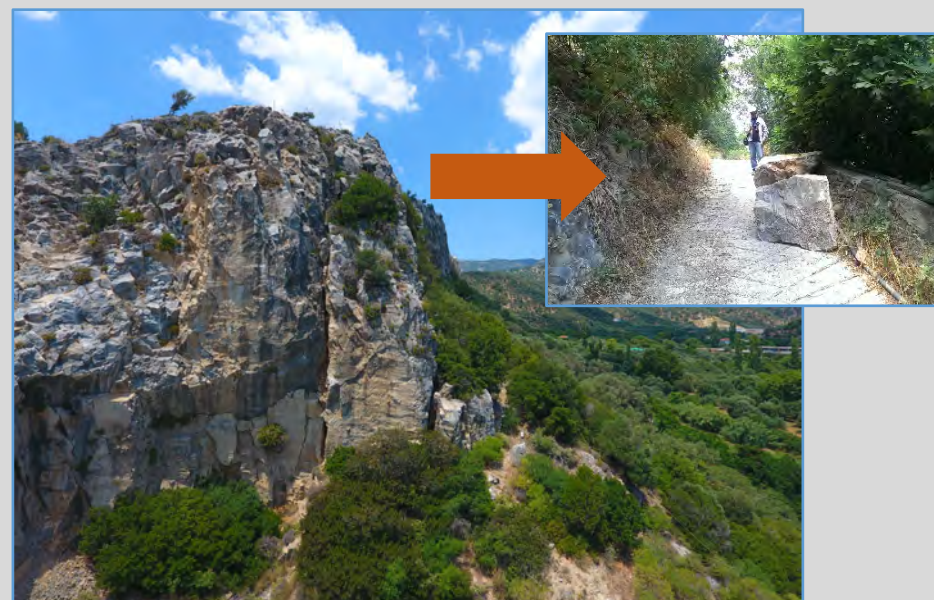
As regards the induced earthquake environmental effects, slope movements and ground cracks were generated in many sites of the affected area as well as seismic waves (tsunami) were reported in Plomari port.

## Earthquake environmental effects– Landslides and Rockfalls
