## Earthquake of June 23, 2020, M 7.4, Oaxaca, Mexico

Velázquez-Bucio M.M., Porfido S., Michetti A.M.

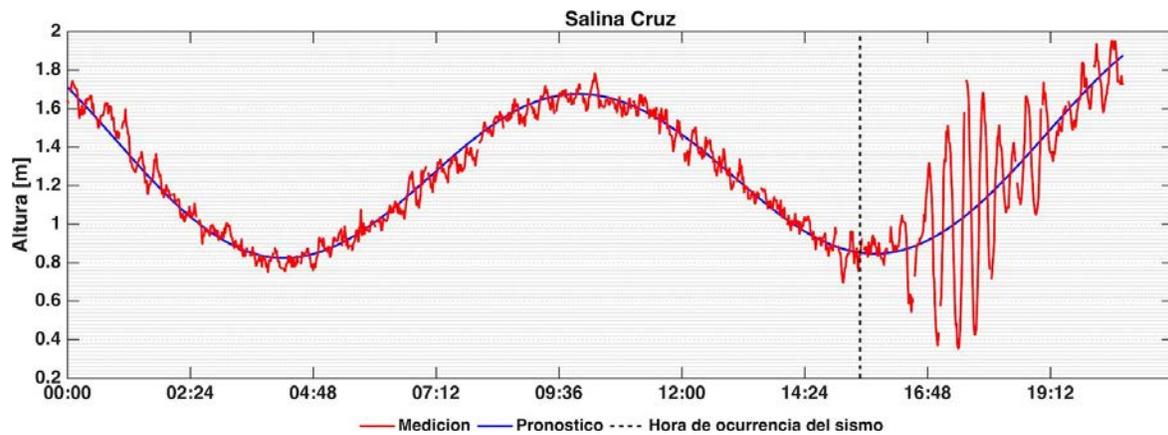
The Mareographic National Service (SMN) registered a moderate tsunami, caused by the earthquake, in some of its stations on the Pacific coast. The maximum variations were registered in the Salina Cruz stations with a maximum of 1.4 m (Figure 12), Huatulco with 0.6 m (Figure 13),

Figure 12: Measured data (red) and astronomical tide forecast (blue) at the Salina Cruz station, Oaxaca. The graph starts at 00:00 UTC, and is possible to see the behavior of the signal prior to the occurrence of the tsunami (SMN).

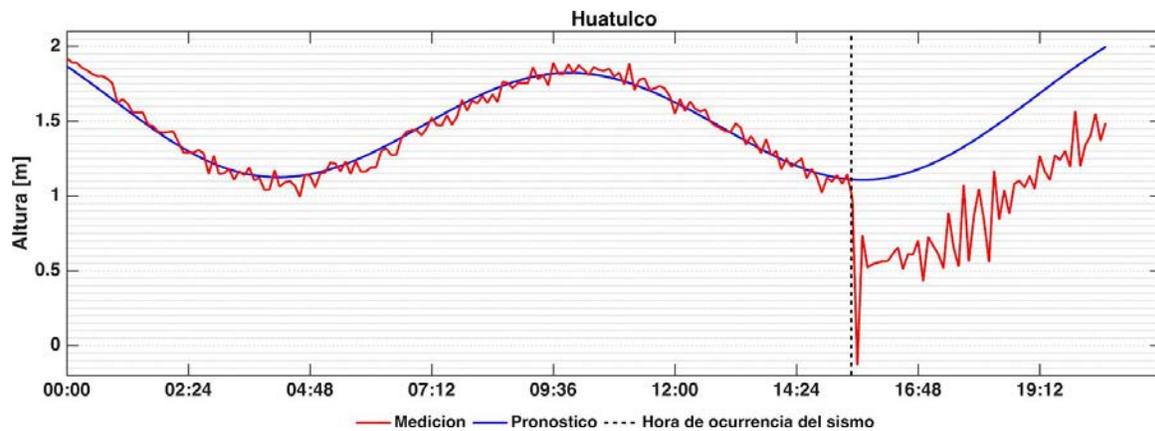
and Puerto Chiapas with 0.26 m, with respect to the level of the tide. They emphasize that in the Huatulco station an abrupt decrease in sea level of approximately 1.25 m was registered, and in addition, a vertical displacement of approximately 0.5511 m, which suggest coastal uplift.

Figure 13: Measured data (red) and astronomical tide forecast (blue) at the Huatulco station, Oaxaca (22 km from the epicenter). The graph starts at 00:00 UTC, and is possible to see the behavior of the signal prior to the occurrence of the tsunami (SMN).

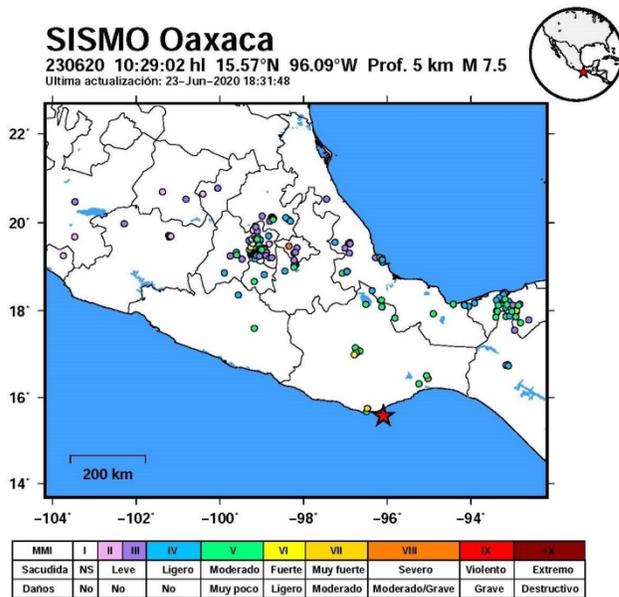
The macroseismic intensity maps published by the SSN (Figure 14) and the USGS (Figure 15), show that the earthquake affected at least 12 states of the republic, more than 700 km away from the epicenter, where possibly some effects have been recorded.

Figure 14. Macro seismic intensity map of the Internet community, made by the Autonomous University of Nuevo León, Faculty of Earth Sciences, taken from the SSN.

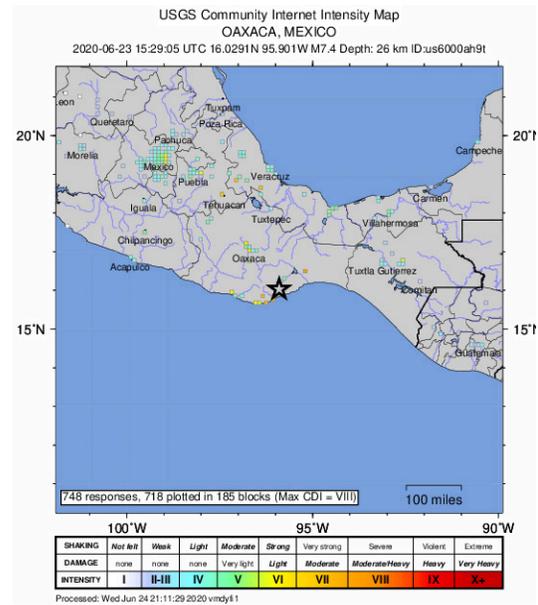
Figure 15. Macro seismic intensity map generated by the “Did You Feel It?” Program. USGS.

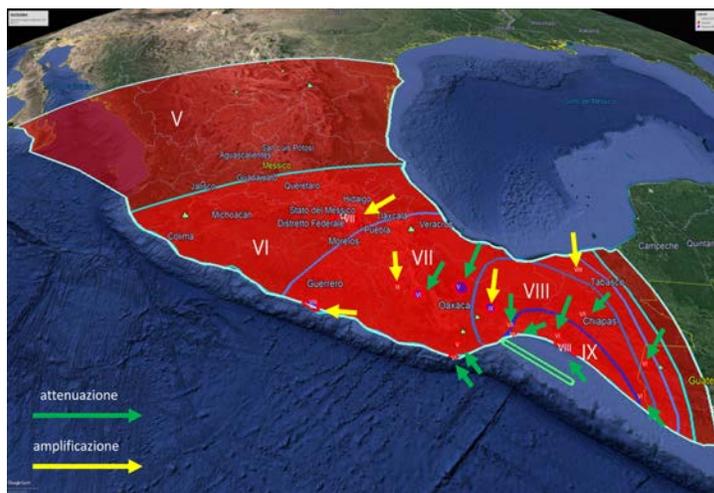
Figure 16. Preliminary intensity map ESI-2007, from analysed earthquake environmental effects (EEE) data of September 8, 2017
